OUTFALL SUMMARY REPORT

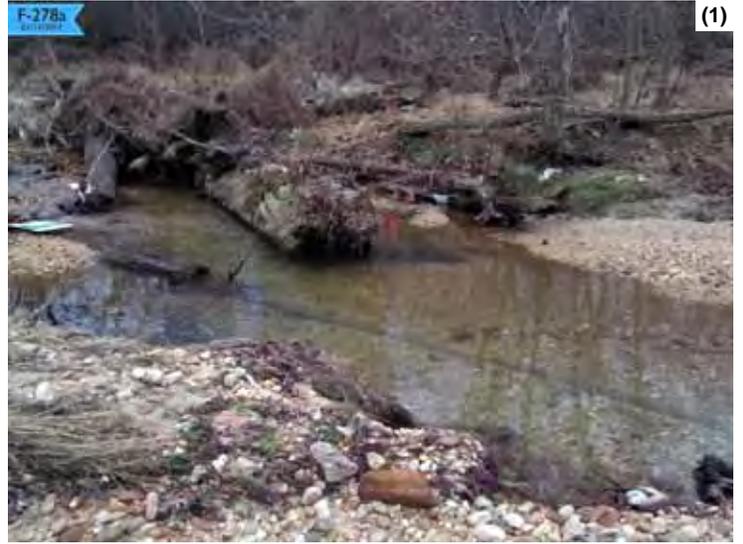
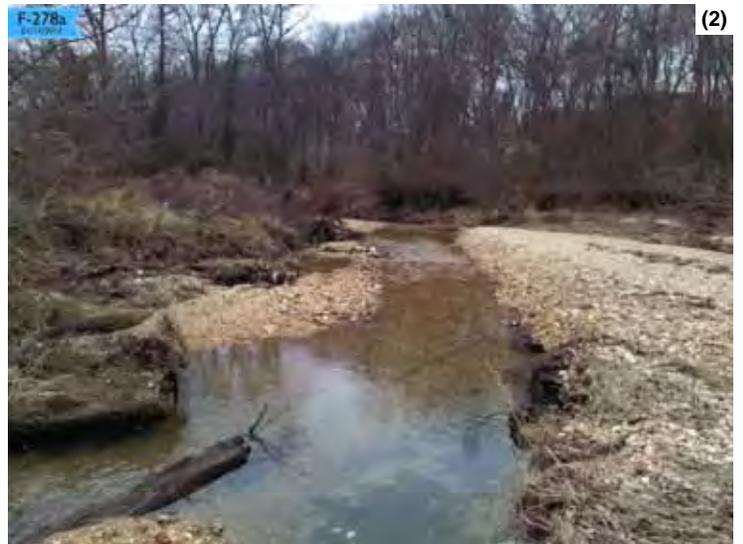
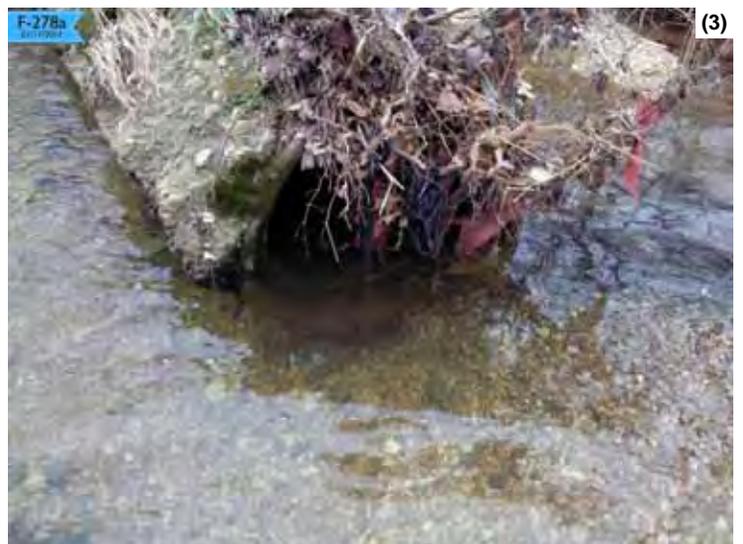
Stream Bank / Pool	<input type="text" value="1"/>	<input type="text" value="Some Erosion"/>	Repairs Recommended? NO
Stream Bank / Pool (x2)	<input type="text" value="2"/>		
Structure	<input type="text" value="2"/>	<input type="text" value="Poor"/>	
Criticality	<input type="text" value="0"/>	<input type="text" value="Normal"/>	
Total Score	<input type="text" value="4"/>	<small>Total = Stream Bank / Pool x2 + Structure + Criticality</small>

Appears to be a broken abandoned SS in the creek.

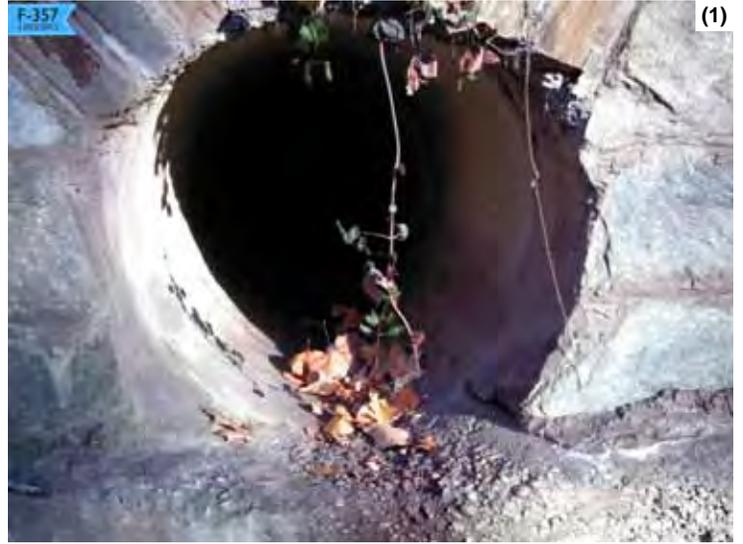
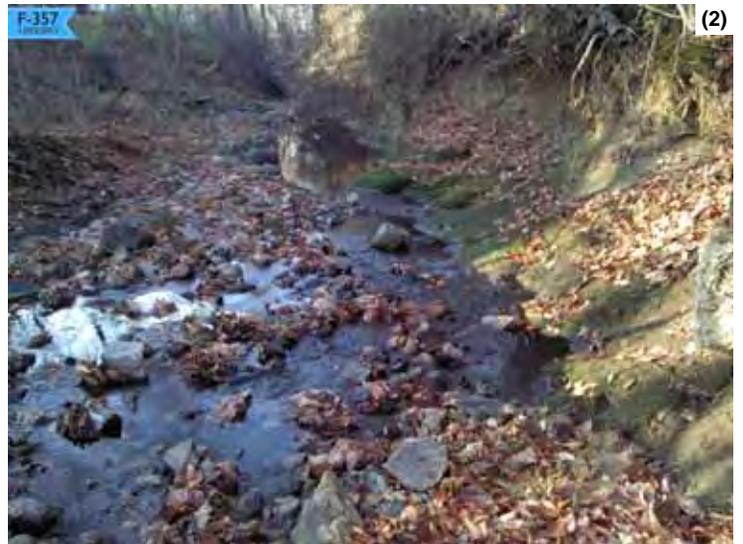
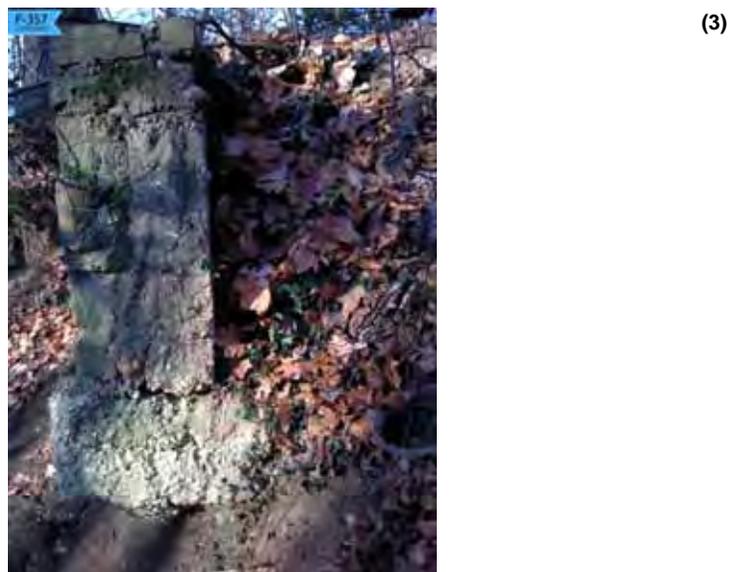
Stream Bank / Pool	<input type="text" value="1"/>	<input type="text" value="Some Erosion"/>	Repairs Recommended? YES
Stream Bank / Pool (x2)	<input type="text" value="2"/>		
Structure	<input type="text" value="1"/>	<input type="text" value="Moderate"/>	
Criticality	<input type="text" value="0"/>	<input type="text" value="Normal"/>	
Total Score	<input type="text" value="3"/>	<small>Total = Stream Bank / Pool x2 + Structure + Criticality</small>

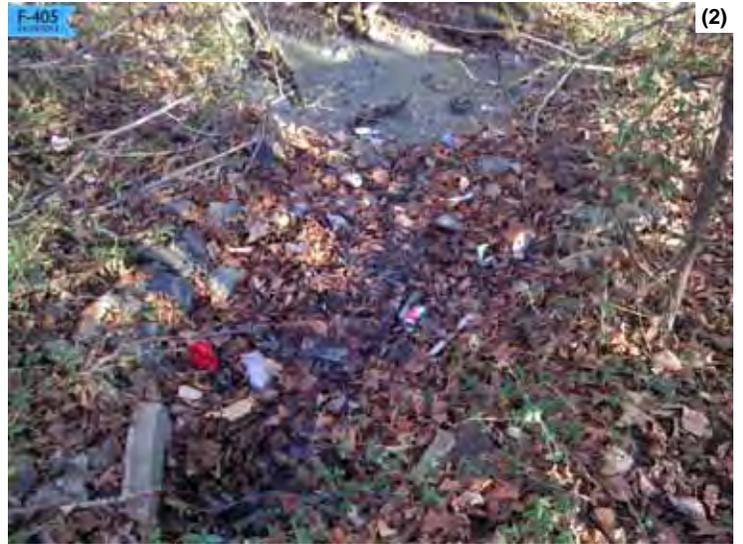
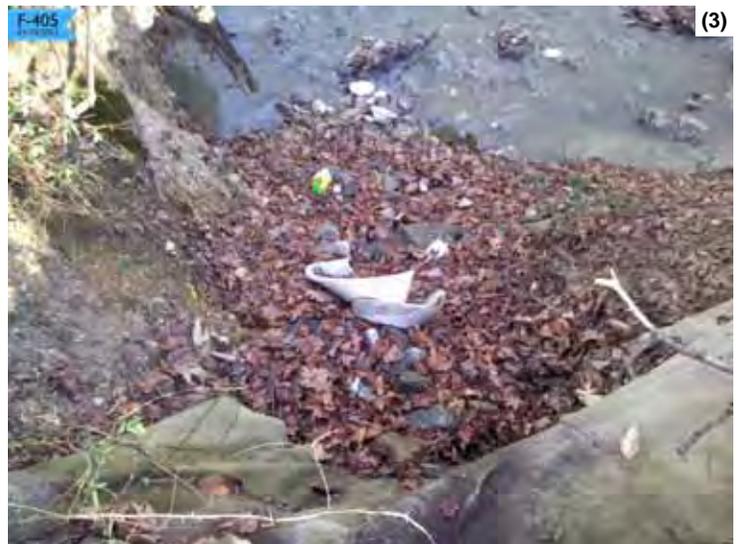
Stream Bank / Pool	<input type="text" value="3"/>	<input type="text" value="Severe Erosion"/>	Repairs Recommended? YES
Stream Bank / Pool (x2)	<input type="text" value="6"/>		
Structure	<input type="text" value="0"/>	<input type="text" value="Excellent / Like New"/>	
Criticality	<input type="text" value="0"/>	<input type="text" value="Normal"/>	
Total Score	<input type="text" value="6"/>	<small>Total = Stream Bank / Pool x2 + Structure + Criticality</small>

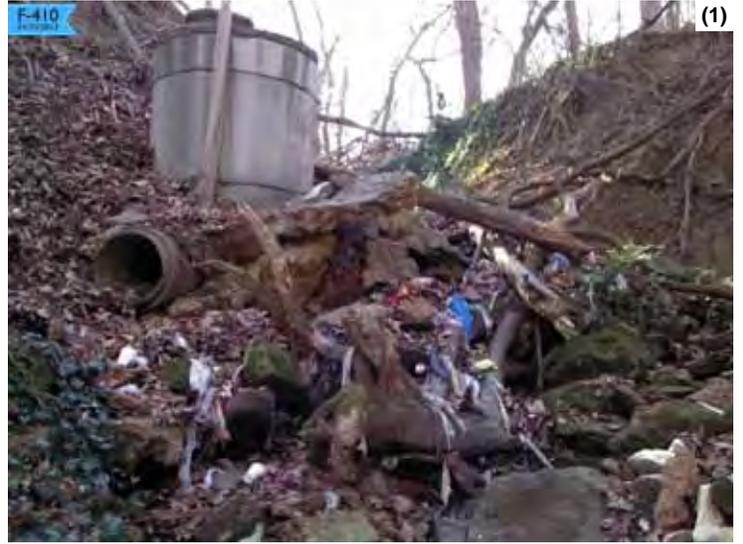
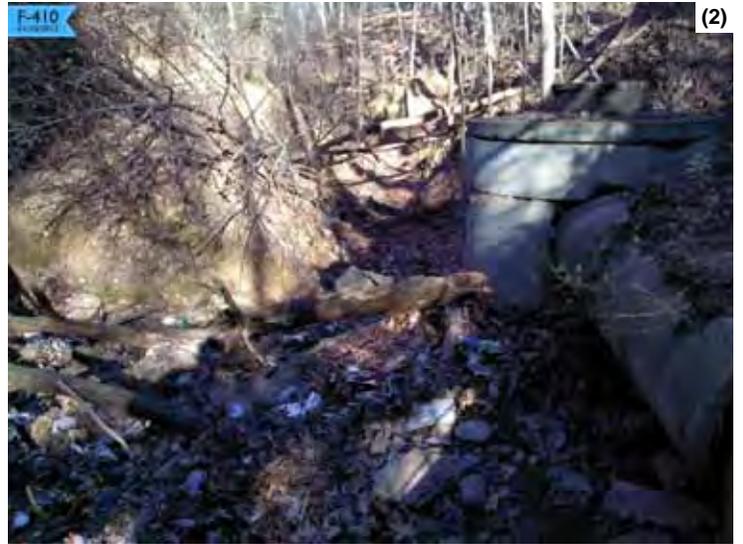
Stream Bank / Pool	<input type="text" value="3"/>	<input type="text" value="Severe Erosion"/>	Repairs Recommended? YES
Stream Bank / Pool (x2)	<input type="text" value="6"/>		
Structure	<input type="text" value="3"/>	<input type="text" value="Very Poor"/>	
Criticality	<input type="text" value="0"/>	<input type="text" value="Normal"/>	
Total Score	<input type="text" value="9"/>	<small>Total = Stream Bank / Pool x2 + Structure + Criticality</small>

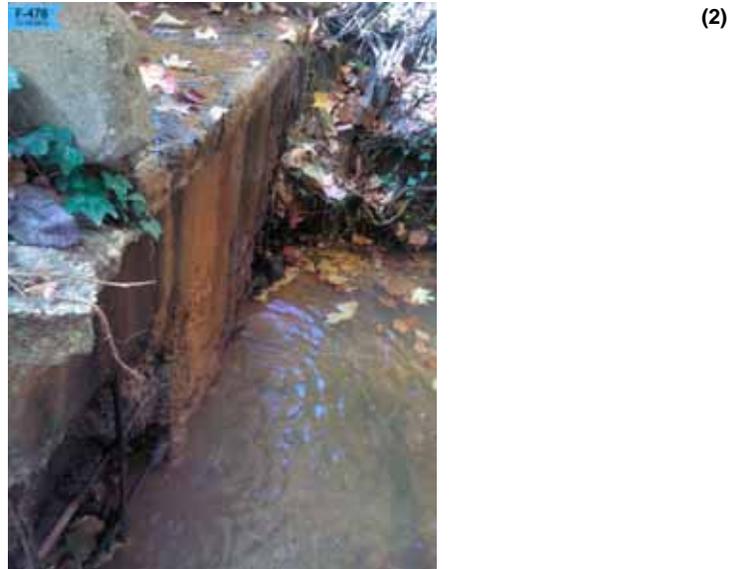
Stream Bank / Pool	<input type="text" value="2"/>	<input type="text" value="Active Erosion"/>	Repairs Recommended? NO
Stream Bank / Pool (x2)	<input type="text" value="4"/>		
Structure	<input type="text" value="1"/>	<input type="text" value="Moderate"/>	
Criticality	<input type="text" value="0"/>	<input type="text" value="Normal"/>	
Total Score	<input type="text" value="5"/>	<small>Total = Stream Bank / Pool x2 + Structure + Criticality</small>

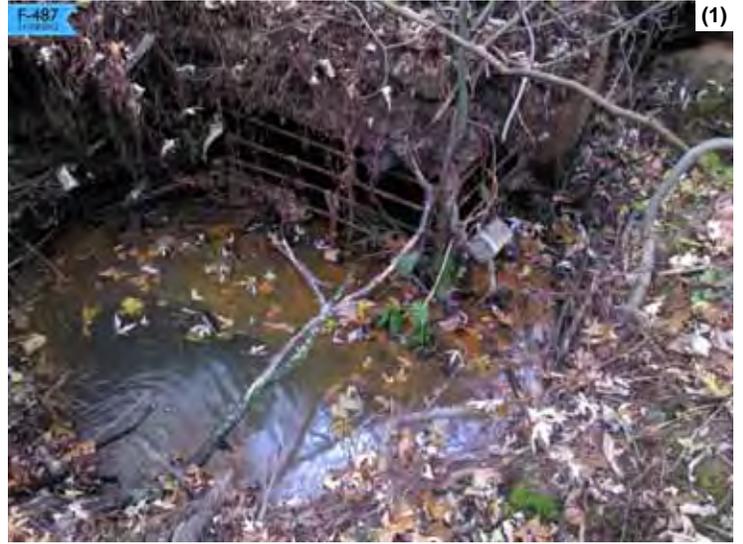
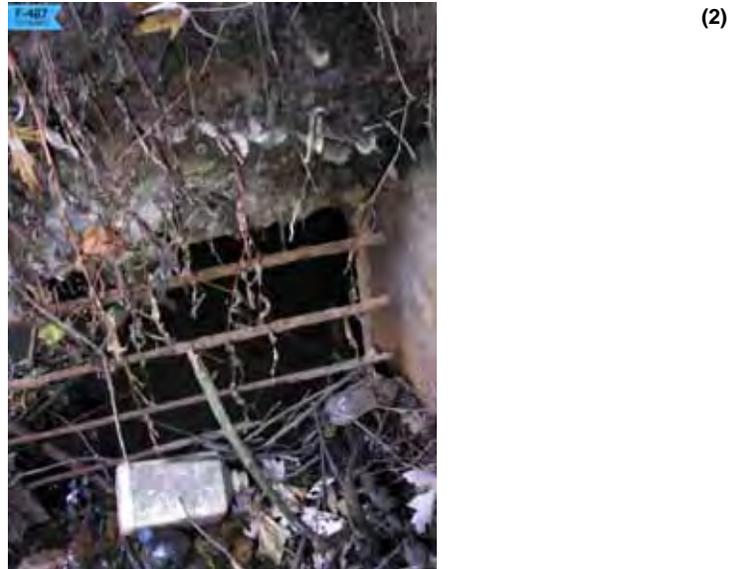
Stream Bank / Pool	<input type="text" value="1"/>	<input type="text" value="Some Erosion"/>	Repairs Recommended? YES
Stream Bank / Pool (x2)	<input type="text" value="2"/>		
Structure	<input type="text" value="2"/>	<input type="text" value="Poor"/>	
Criticality	<input type="text" value="0"/>	<input type="text" value="Normal"/>	
Total Score	<input type="text" value="4"/>	<small>Total = Stream Bank / Pool x2 + Structure + Criticality</small>

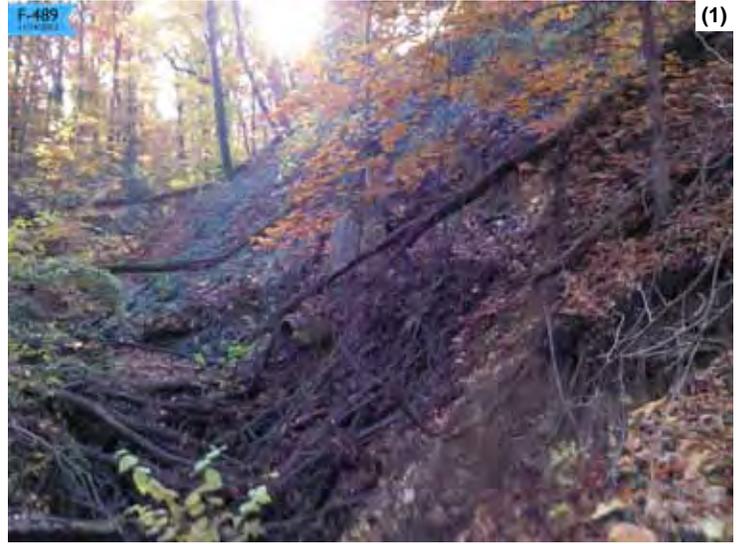
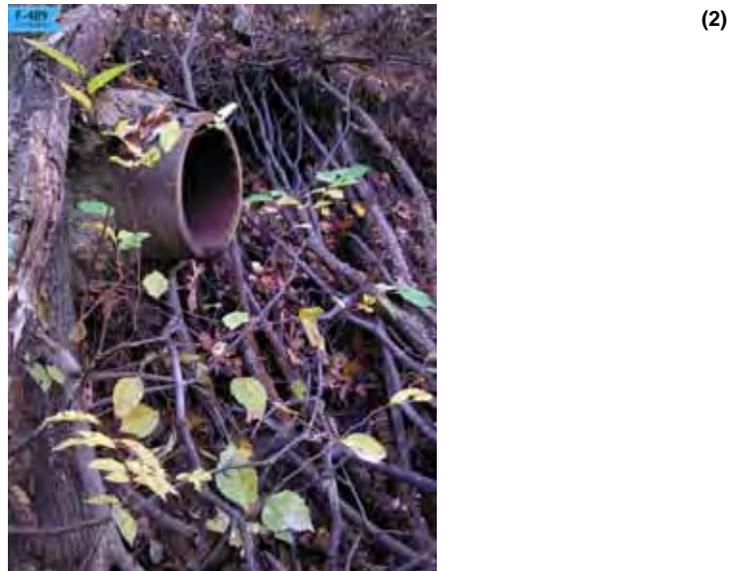
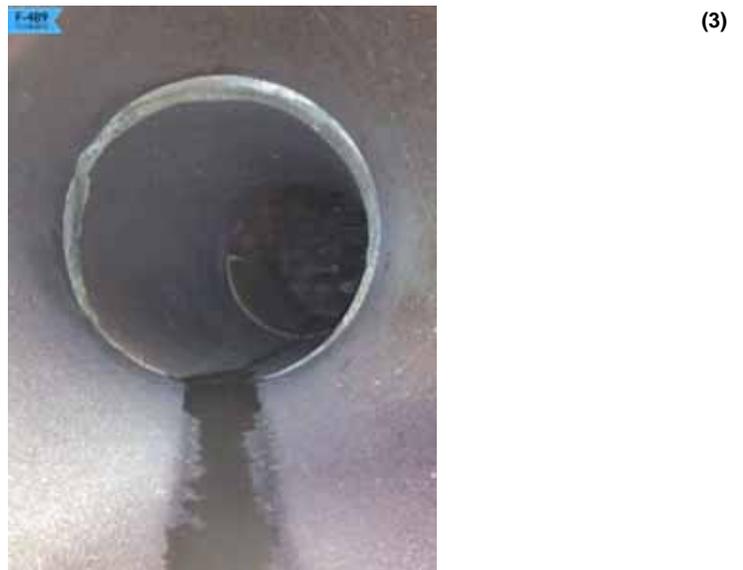
Stream Bank / Pool	<input type="text" value="2"/>	<input type="text" value="Active Erosion"/>	Repairs Recommended? YES
Stream Bank / Pool (x2)	<input type="text" value="4"/>		
Structure	<input type="text" value="2"/>	<input type="text" value="Poor"/>	
Criticality	<input type="text" value="0"/>	<input type="text" value="Normal"/>	
Total Score	<input type="text" value="6"/>	<i>Total = Stream Bank / Pool x2 + Structure + Criticality</i>
