OUTFALL SUMMARY REPORT

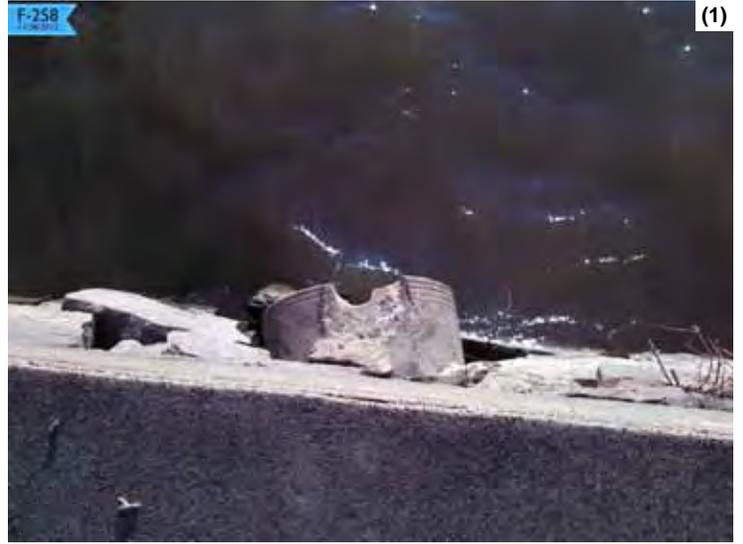
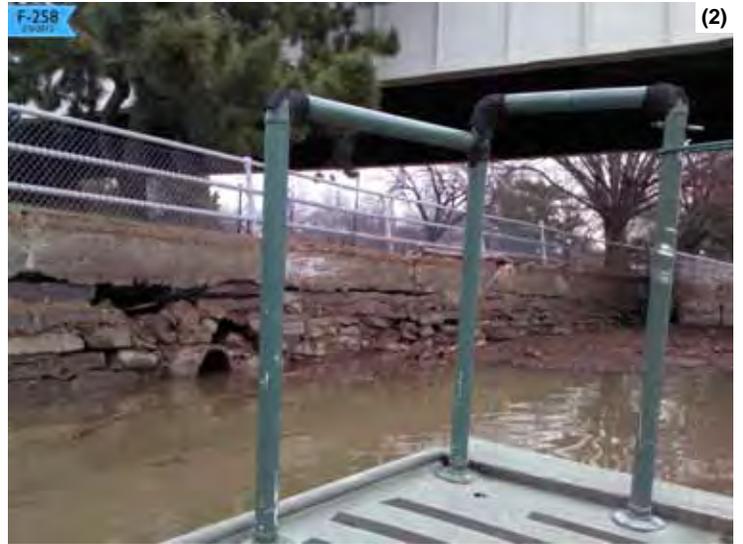
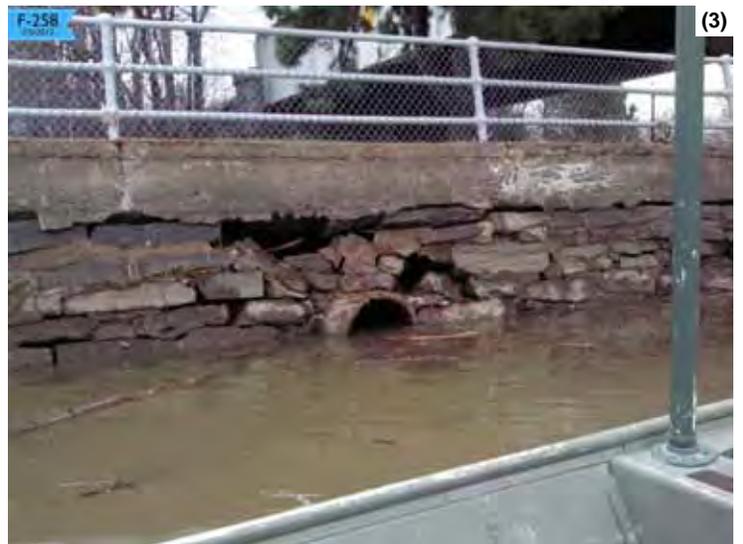
Stream Bank / Pool	<input type="text" value="0"/>	<input type="text" value="Stable"/>	Repairs Recommended? NO
Stream Bank / Pool (x2)	<input type="text" value="0"/>		
Structure	<input type="text" value="1"/>	<input type="text" value="Moderate"/>	
Criticality	<input type="text" value="1"/>	<input type="text" value="Important"/>	
Total Score	<input type="text" value="2"/>	<small>Total = Stream Bank / Pool x2 + Structure + Criticality</small>

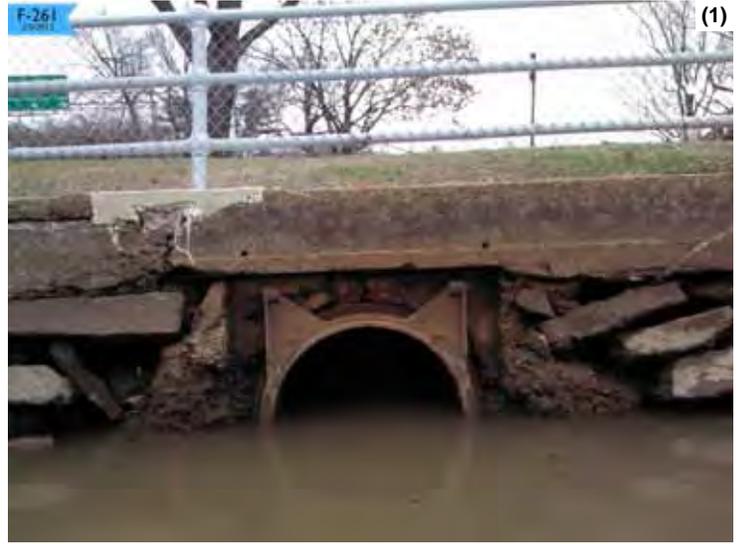
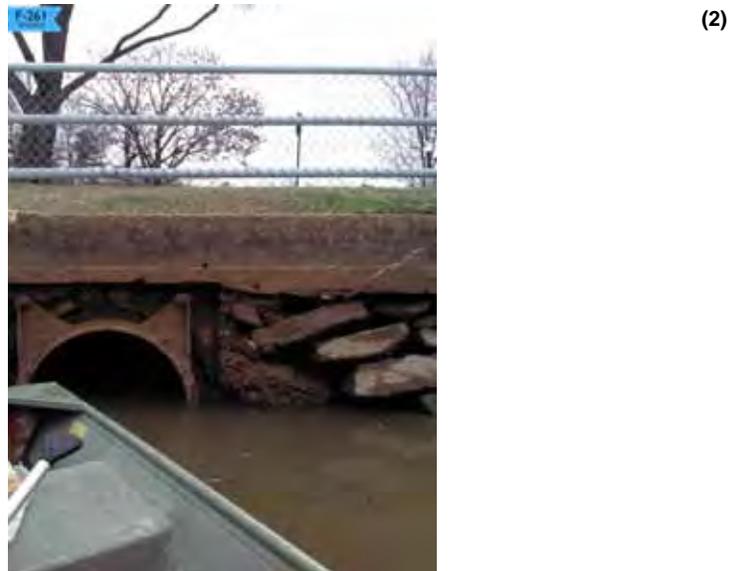
Missing flap gate.

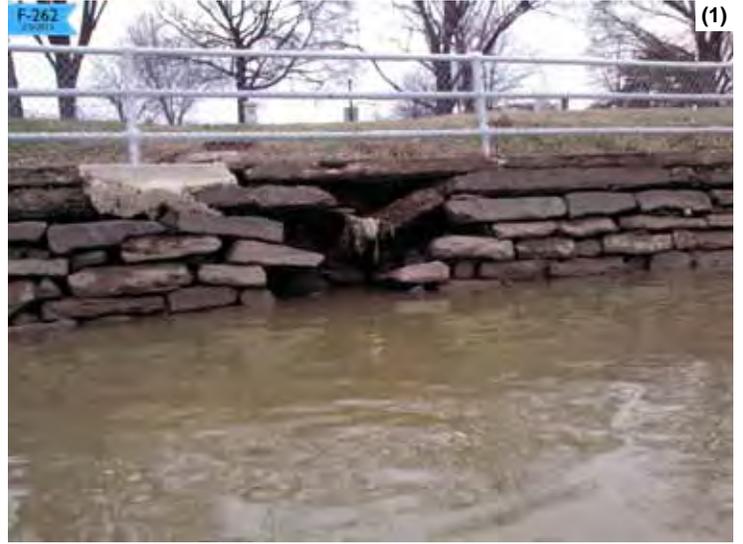
(1)

Stream Bank / Pool	<input type="text" value="0"/>	<input type="text" value="Stable"/>	Repairs Recommended? NO
Stream Bank / Pool (x2)	<input type="text" value="0"/>		
Structure	<input type="text" value="2"/>	<input type="text" value="Poor"/>	
Criticality	<input type="text" value="0"/>	<input type="text" value="Normal"/>	
Total Score	<input type="text" value="2"/>	<small>Total = Stream Bank / Pool x2 + Structure + Criticality</small>

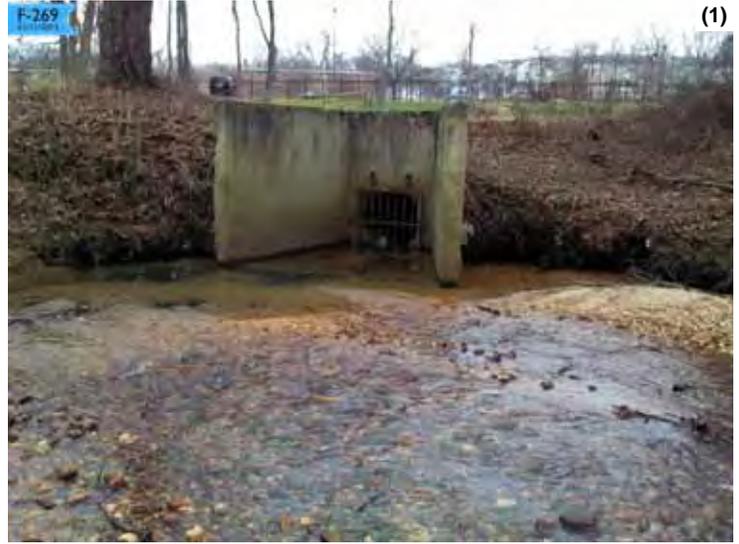
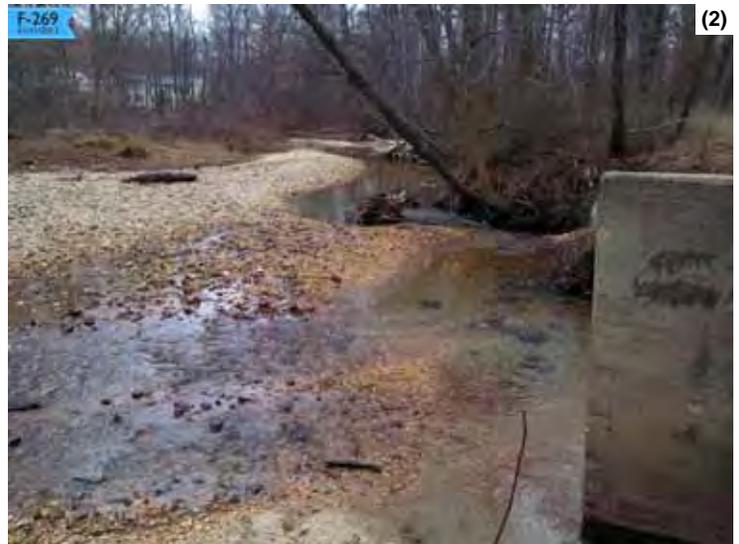
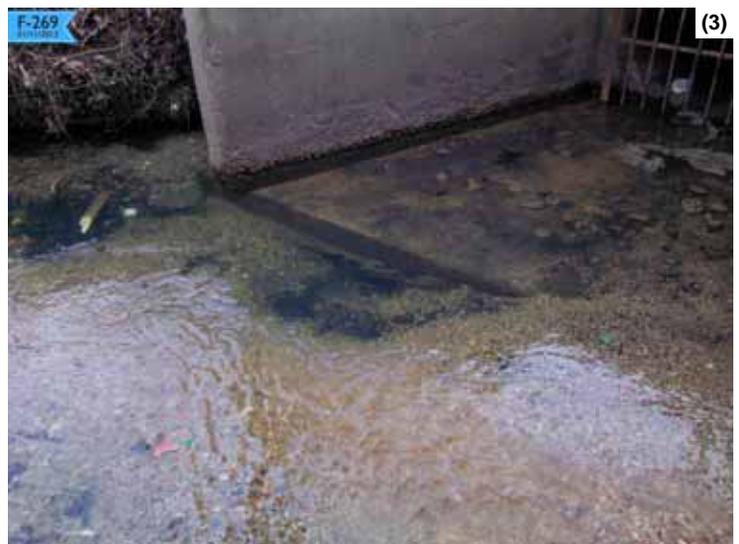
Stream Bank / Pool	<input type="text" value="2"/>	<input type="text" value="Active Erosion"/>	Repairs Recommended? YES
Stream Bank / Pool (x2)	<input type="text" value="4"/>		
Structure	<input type="text" value="0"/>	<input type="text" value="Excellent / Like New"/>	
Criticality	<input type="text" value="0"/>	<input type="text" value="Normal"/>	
Total Score	<input type="text" value="4"/>	<small>Total = Stream Bank / Pool x2 + Structure + Criticality</small>

Description of Repair Approach

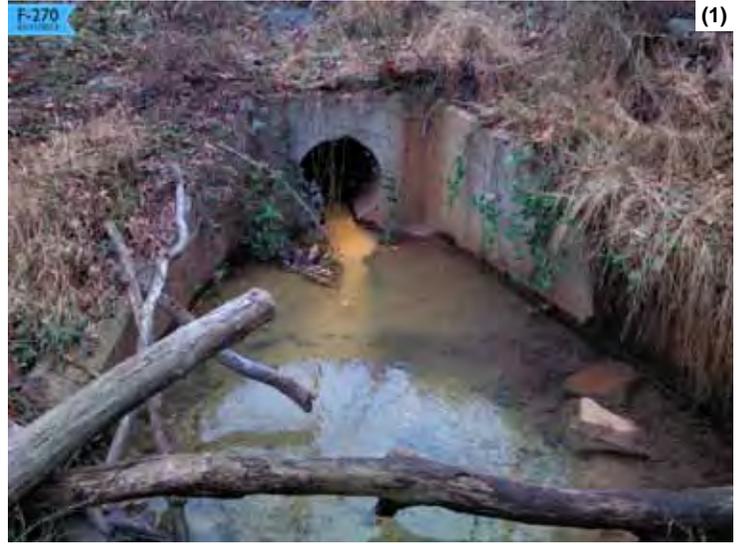
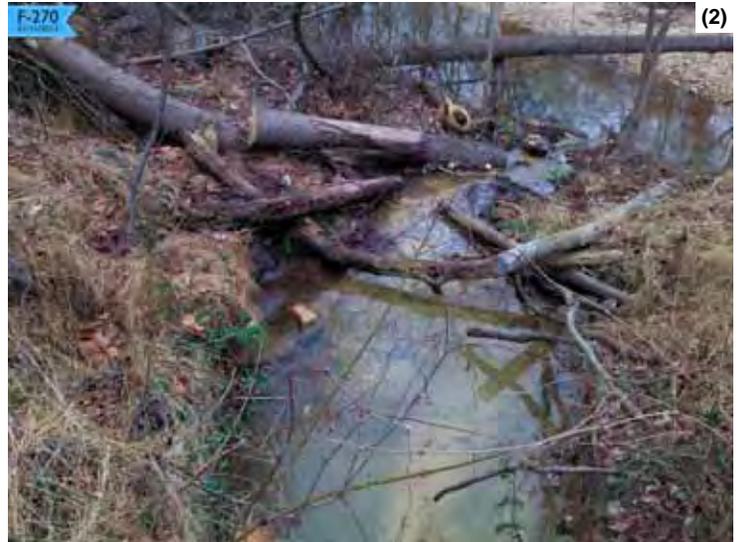
Water from magnolia bog behind outfall flows over wingwalls in wet weather conditions.

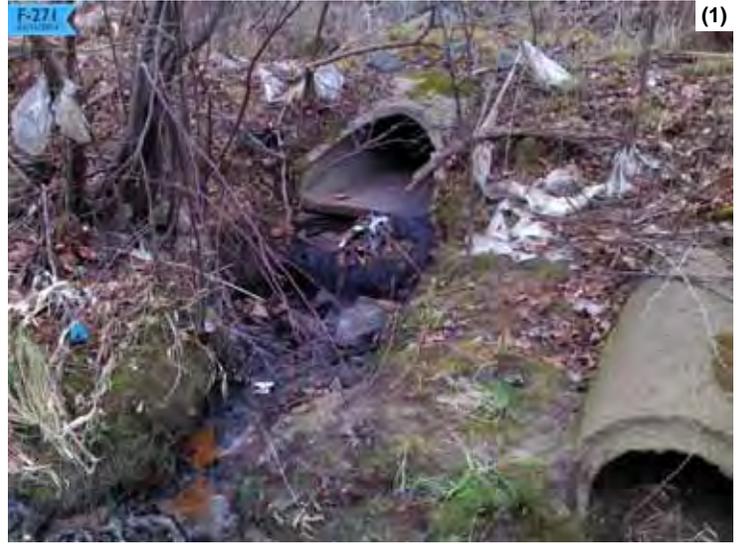
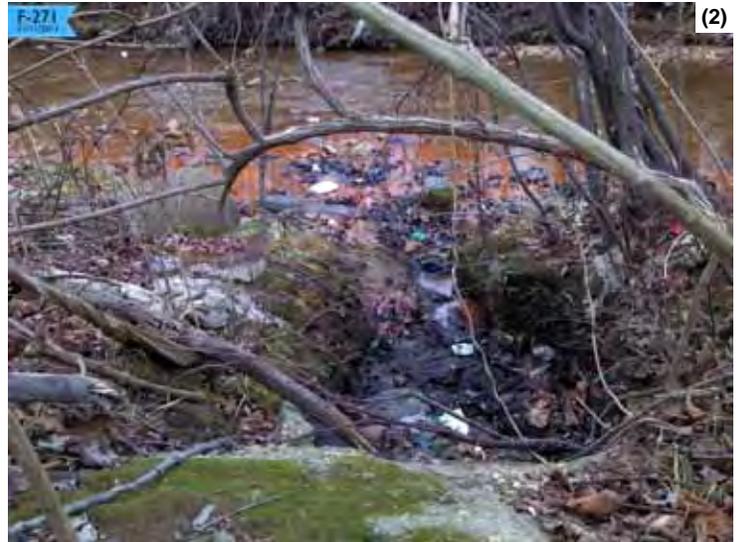
Stream Bank / Pool	<input type="text" value="1"/>	<input type="text" value="Some Erosion"/>	Repairs Recommended? NO
Stream Bank / Pool (x2)	<input type="text" value="2"/>		
Structure	<input type="text" value="0"/>	<input type="text" value="Excellent / Like New"/>	
Criticality	<input type="text" value="0"/>	<input type="text" value="Normal"/>	
Total Score	<input type="text" value="2"/>	<small>Total = Stream Bank / Pool x2 + Structure + Criticality</small>

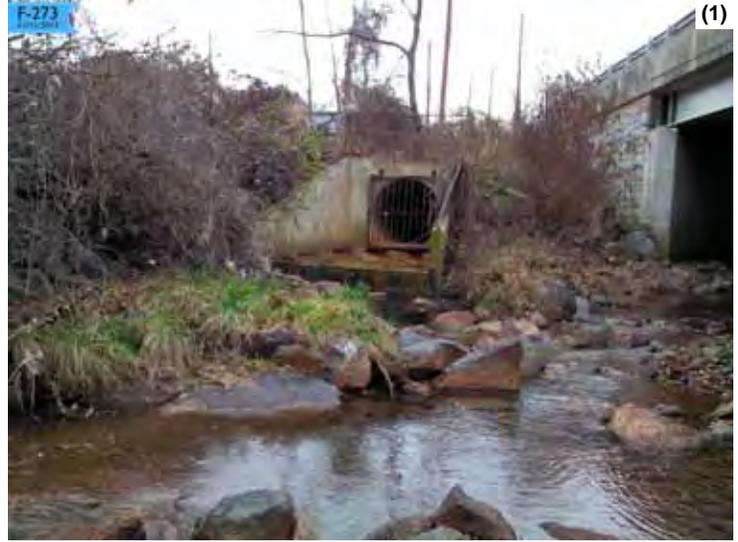
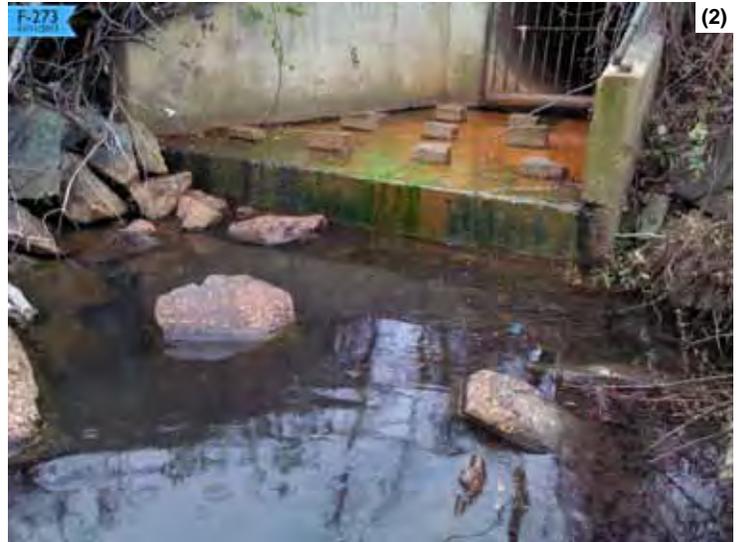
Stream Bank / Pool	<input type="text" value="1"/>	<input type="text" value="Some Erosion"/>	Repairs Recommended? NO
Stream Bank / Pool (x2)	<input type="text" value="2"/>		
Structure	<input type="text" value="0"/>	<input type="text" value="Excellent / Like New"/>	
Criticality	<input type="text" value="0"/>	<input type="text" value="Normal"/>	
Total Score	<input type="text" value="2"/>	<small>Total = Stream Bank / Pool x2 + Structure + Criticality</small>

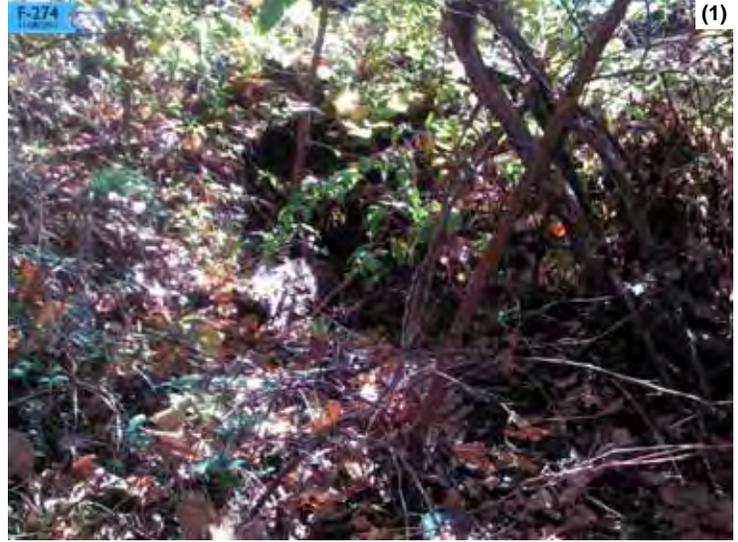
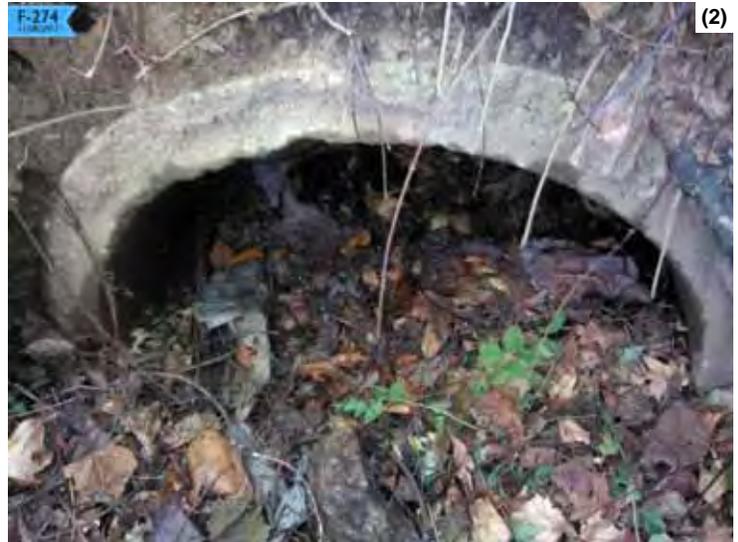
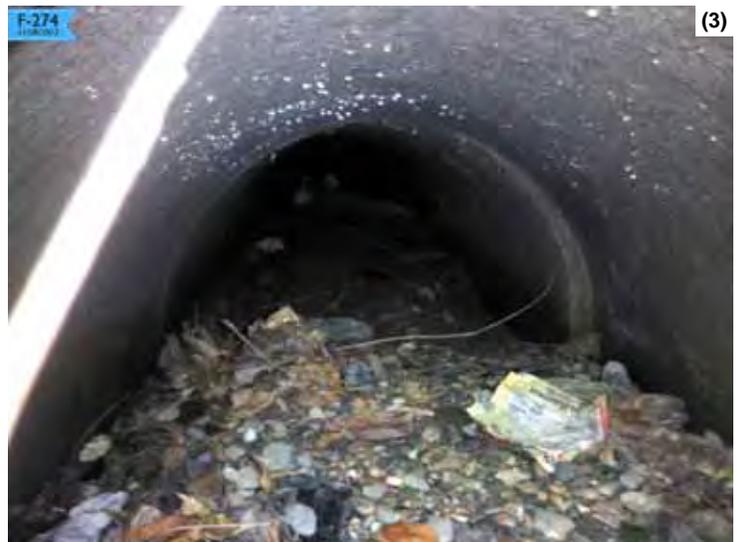
Stream Bank / Pool	<input type="text" value="0"/>	<input type="text" value="Stable"/>	Repairs Recommended? NO
Stream Bank / Pool (x2)	<input type="text" value="0"/>		
Structure	<input type="text" value="2"/>	<input type="text" value="Poor"/>	
Criticality	<input type="text" value="0"/>	<input type="text" value="Normal"/>	
Total Score	<input type="text" value="2"/>	<small>Total = Stream Bank / Pool x2 + Structure + Criticality</small>

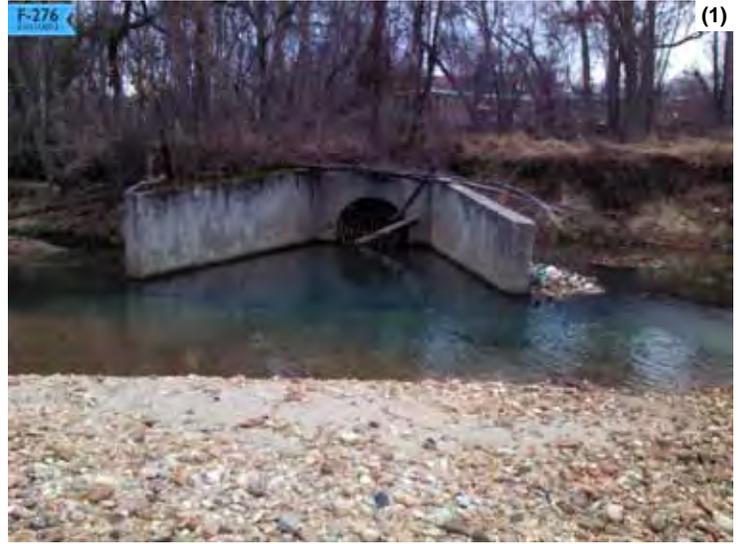
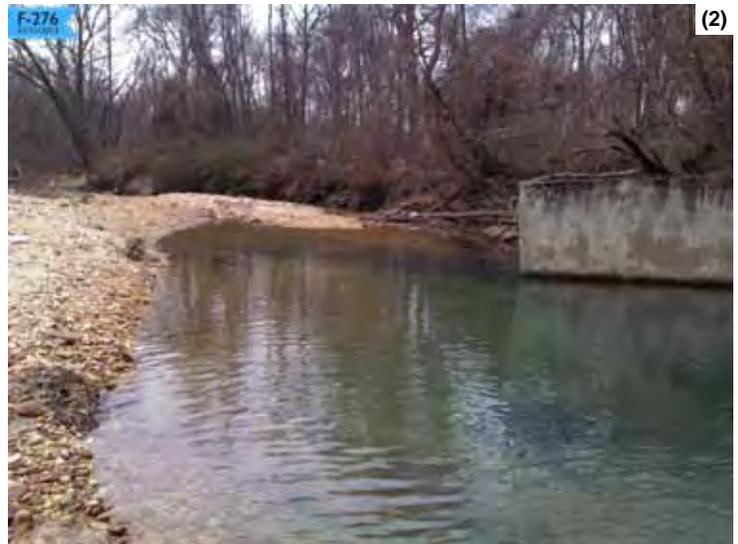
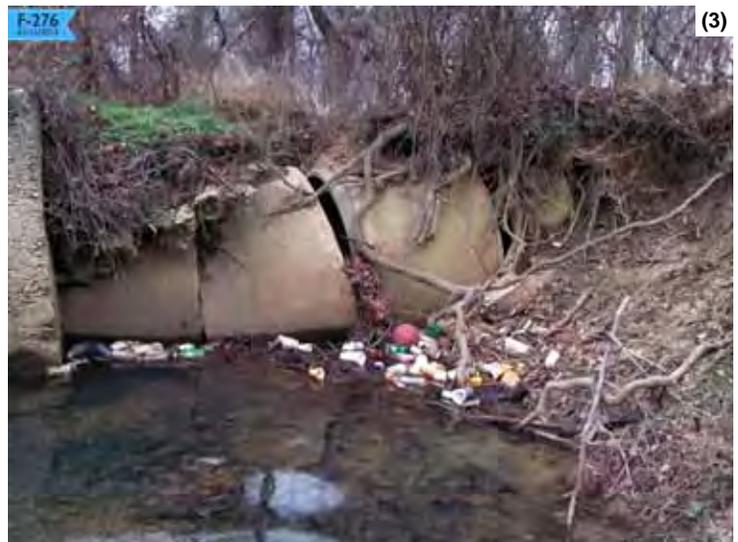
Stream Bank / Pool	<input type="text" value="2"/>	<input type="text" value="Active Erosion"/>	Repairs Recommended? <input type="text" value="YES"/>
Stream Bank / Pool (x2)	<input type="text" value="4"/>		
Structure	<input type="text" value="2"/>	<input type="text" value="Poor"/>	
Criticality	<input type="text" value="0"/>	<input type="text" value="Normal"/>	
Total Score	<input type="text" value="6"/>	<small>Total = Stream Bank / Pool x2 + Structure + Criticality</small>

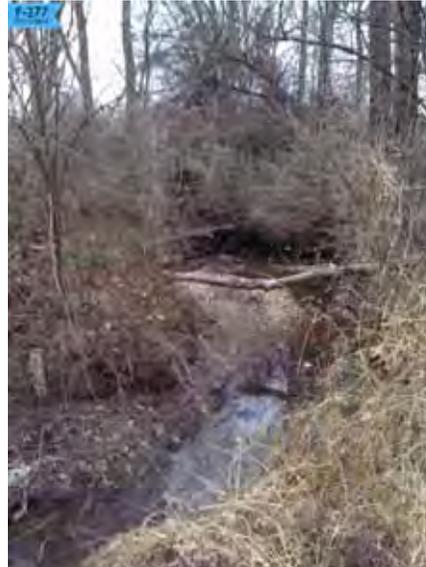
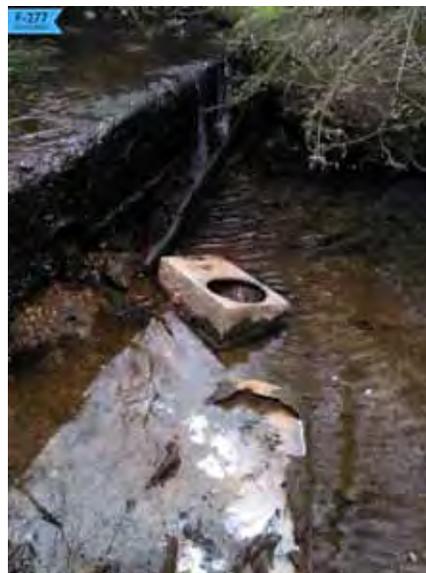
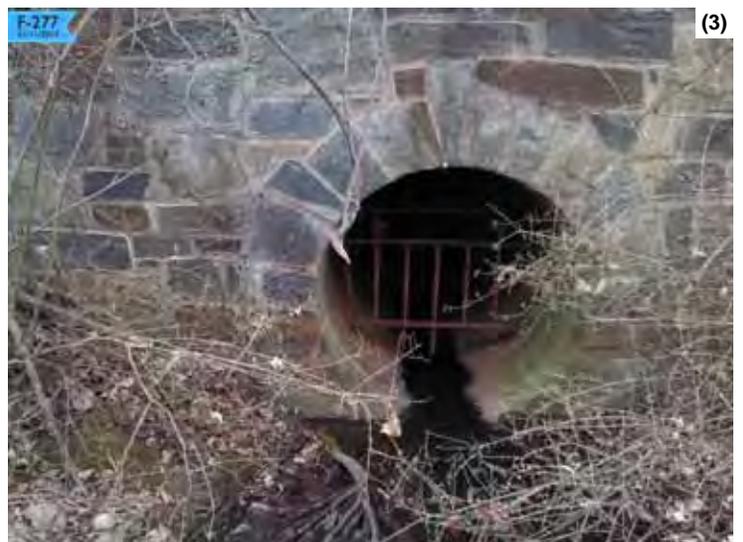
Stream Bank / Pool	<input type="text" value="2"/>	<input type="text" value="Active Erosion"/>	Repairs Recommended? YES
Stream Bank / Pool (x2)	<input type="text" value="4"/>		
Structure	<input type="text" value="0"/>	<input type="text" value="Excellent / Like New"/>	
Criticality	<input type="text" value="0"/>	<input type="text" value="Normal"/>	
Total Score	<input type="text" value="4"/>	<small>Total = Stream Bank / Pool x2 + Structure + Criticality</small>

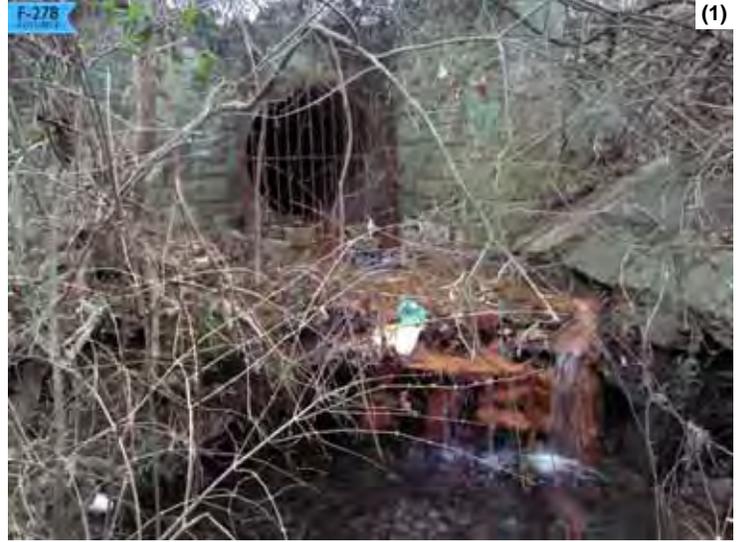
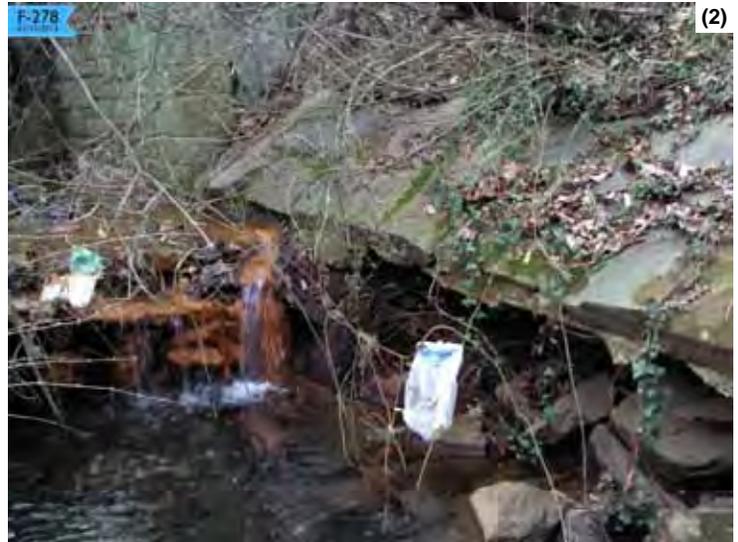
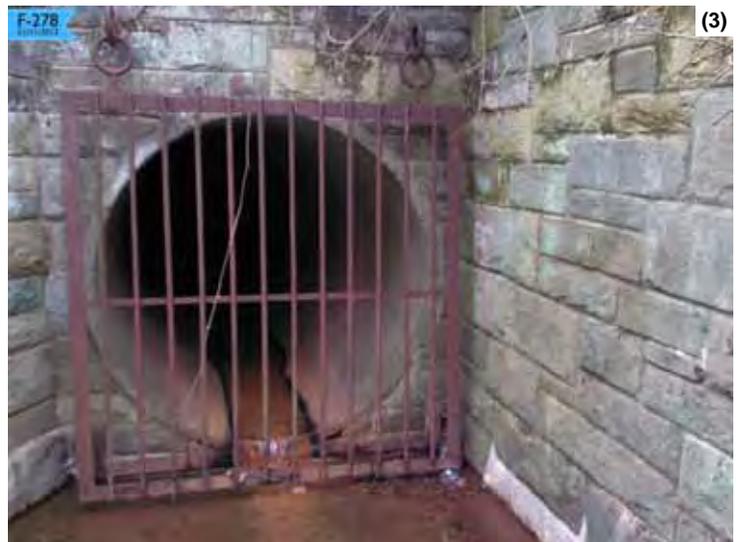
Stream Bank / Pool	<input type="text" value="2"/>	Active Erosion	Repairs Recommended? YES
Stream Bank / Pool (x2)	<input type="text" value="4"/>		
Structure	<input type="text" value="1"/>	Moderate	
Criticality	<input type="text" value="0"/>	Normal	
Total Score	<input type="text" value="5"/>	<small>Total = Stream Bank / Pool x2 + Structure + Criticality</small>

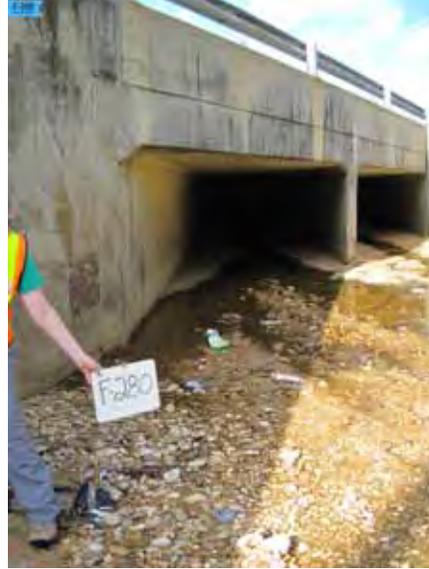
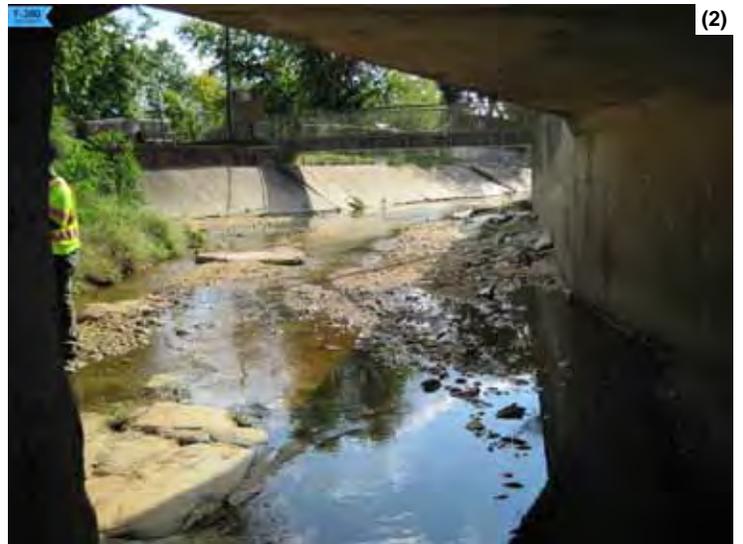
Stream Bank / Pool	<input type="text" value="0"/>	<input type="text" value="Stable"/>	Repairs Recommended? NO
Stream Bank / Pool (x2)	<input type="text" value="0"/>		
Structure	<input type="text" value="0"/>	<input type="text" value="Excellent / Like New"/>	
Criticality	<input type="text" value="0"/>	<input type="text" value="Normal"/>	
Total Score	<input type="text" value="0"/>	<i>Total = Stream Bank / Pool x2 + Structure + Criticality</i>

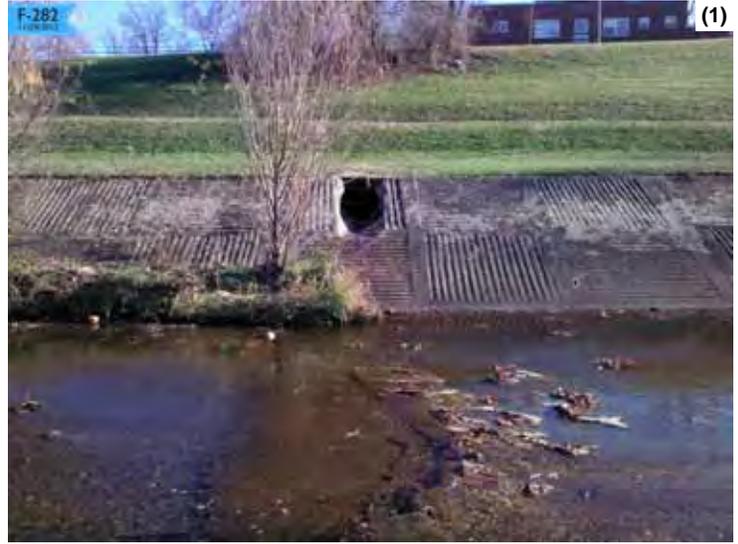
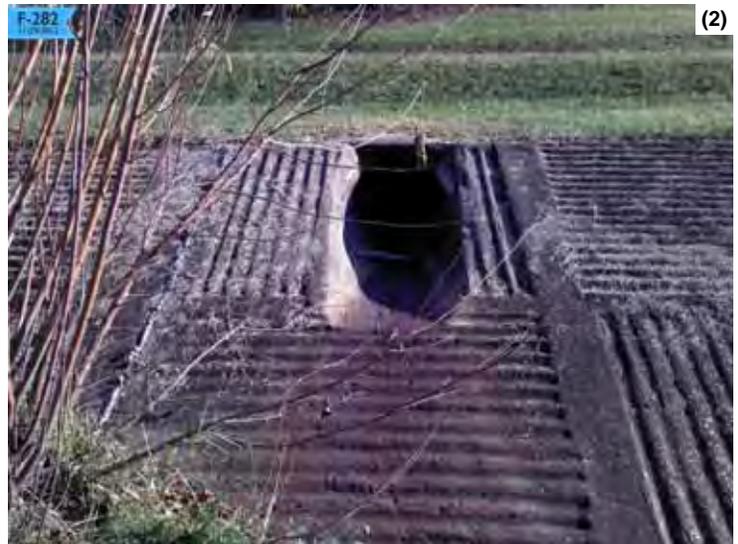
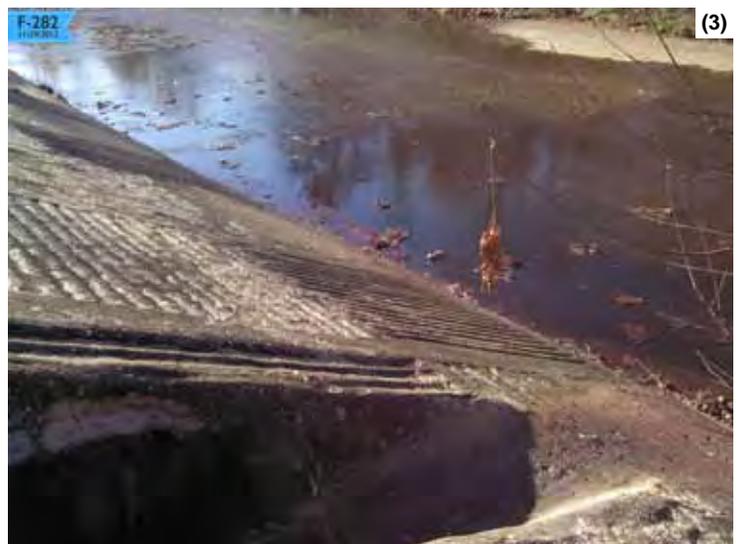
Rust colored stain on outfall

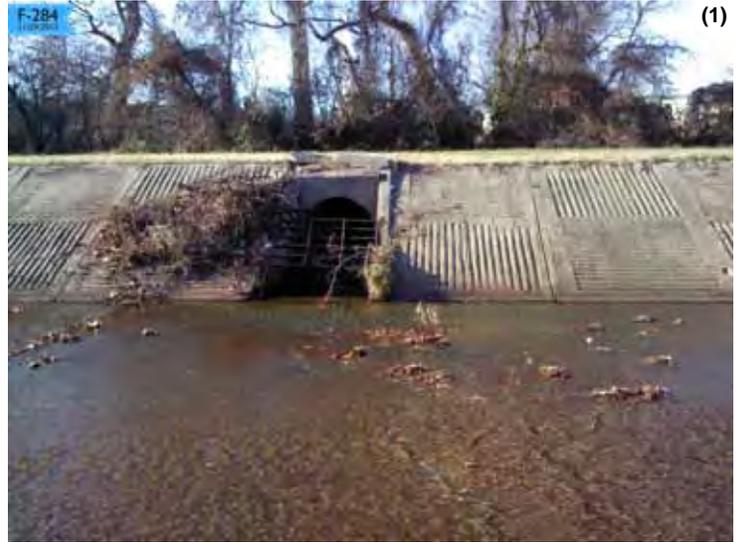
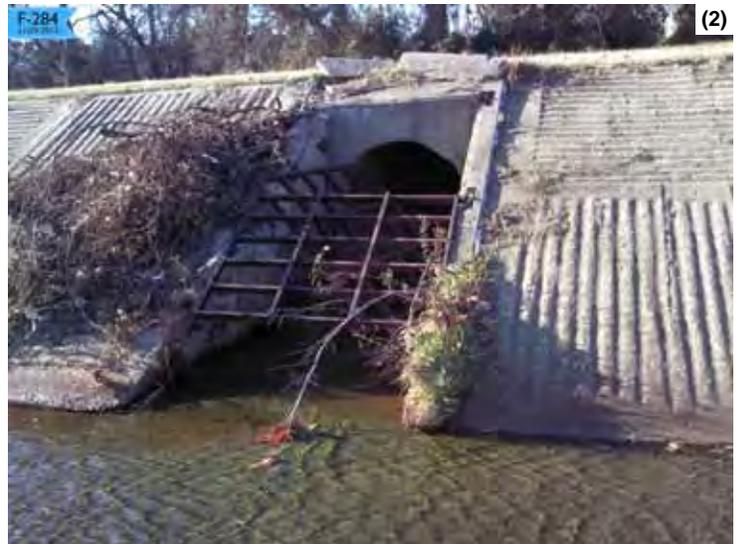
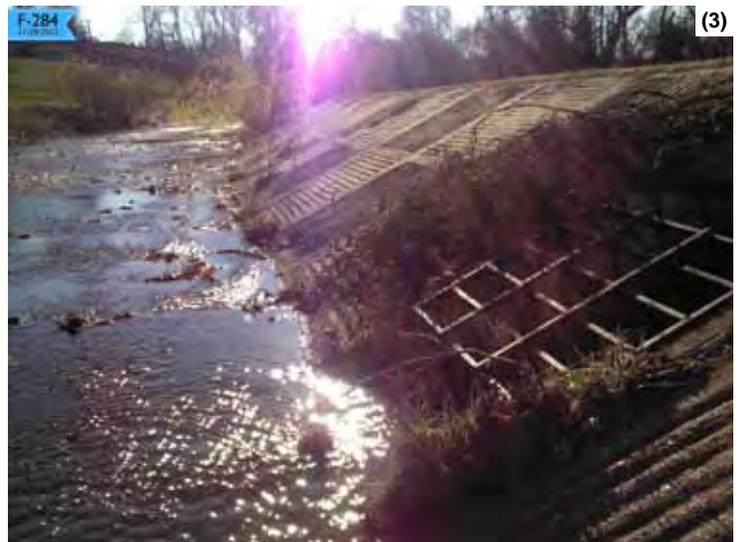
Stream Bank / Pool	<input type="text" value="0"/>	<input type="text" value="Stable"/>	Repairs Recommended? YES
Stream Bank / Pool (x2)	<input type="text" value="0"/>		
Structure	<input type="text" value="2"/>	<input type="text" value="Poor"/>	
Criticality	<input type="text" value="1"/>	<input type="text" value="Important"/>	
Total Score	<input type="text" value="3"/>	<small>Total = Stream Bank / Pool x2 + Structure + Criticality</small>

Left wingwall and top wall are broken; erosion behind wall likely to progress in future. Repair security/safety gate.

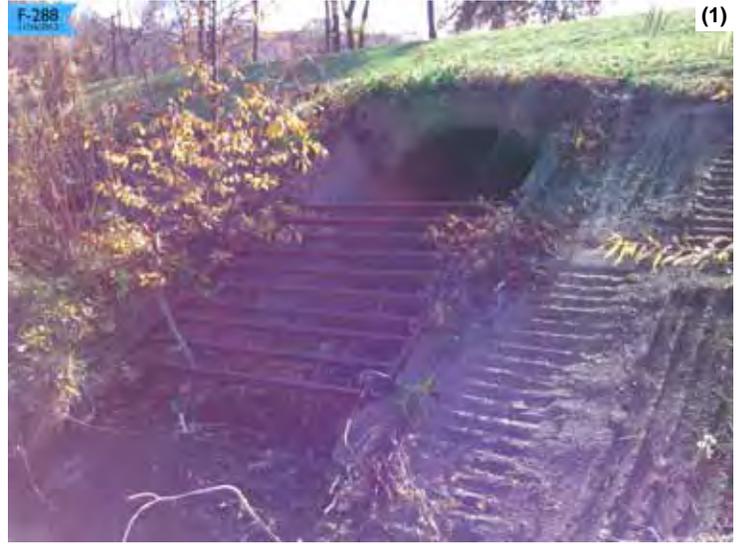
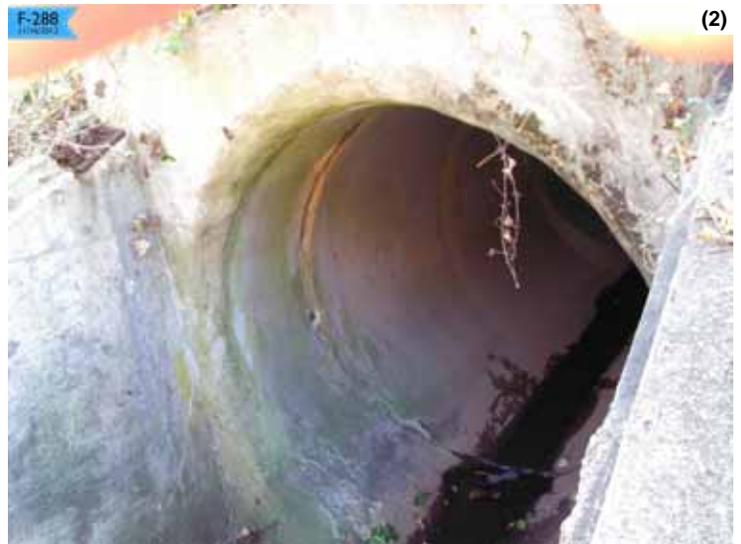
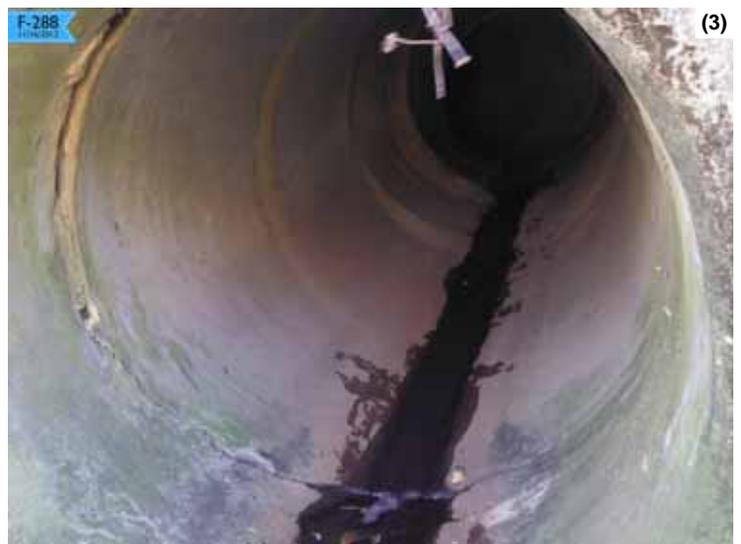
Stream Bank / Pool	<input type="text" value="0"/>	<input type="text" value="Stable"/>	Repairs Recommended? NO
Stream Bank / Pool (x2)	<input type="text" value="0"/>		
Structure	<input type="text" value="1"/>	<input type="text" value="Moderate"/>	
Criticality	<input type="text" value="0"/>	<input type="text" value="Normal"/>	
Total Score	<input type="text" value="1"/>	<small>Total = Stream Bank / Pool x2 + Structure + Criticality</small>

Missing a section of the security gate.

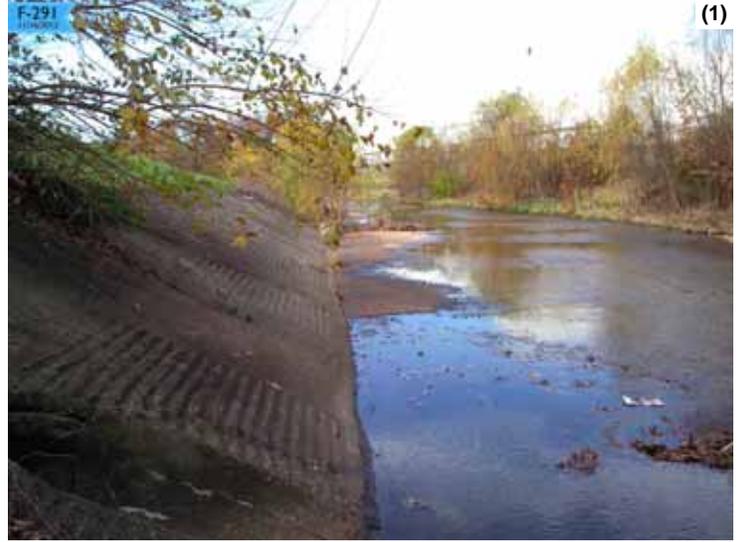
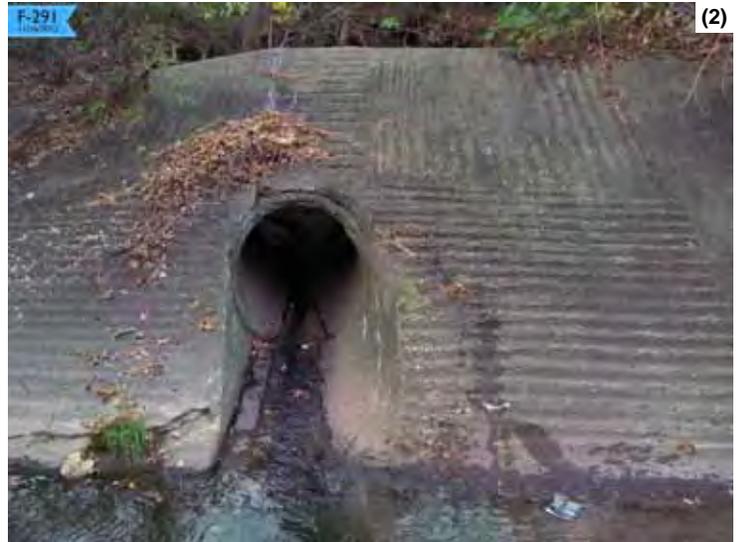
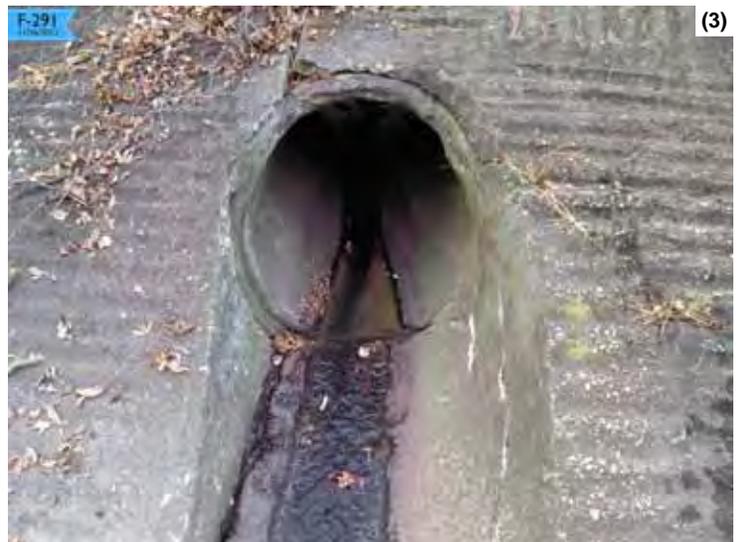
Stream Bank / Pool	<input type="text" value="0"/>	<input type="text" value="Stable"/>	Repairs Recommended? YES
Stream Bank / Pool (x2)	<input type="text" value="0"/>		
Structure	<input type="text" value="3"/>	<input type="text" value="Very Poor"/>	
Criticality	<input type="text" value="1"/>	<input type="text" value="Important"/>	
Total Score	<input type="text" value="4"/>	<small>Total = Stream Bank / Pool x2 + Structure + Criticality</small>

Significant erosion and undercutting behind wall has led to failure of storm manhole.

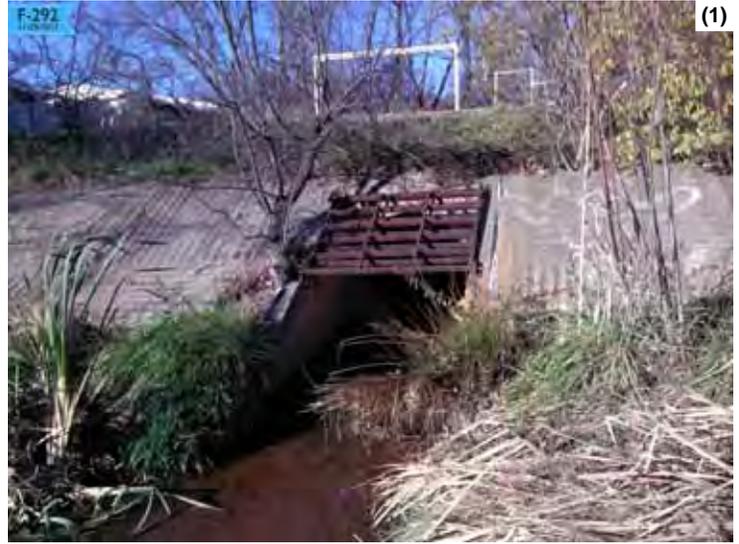
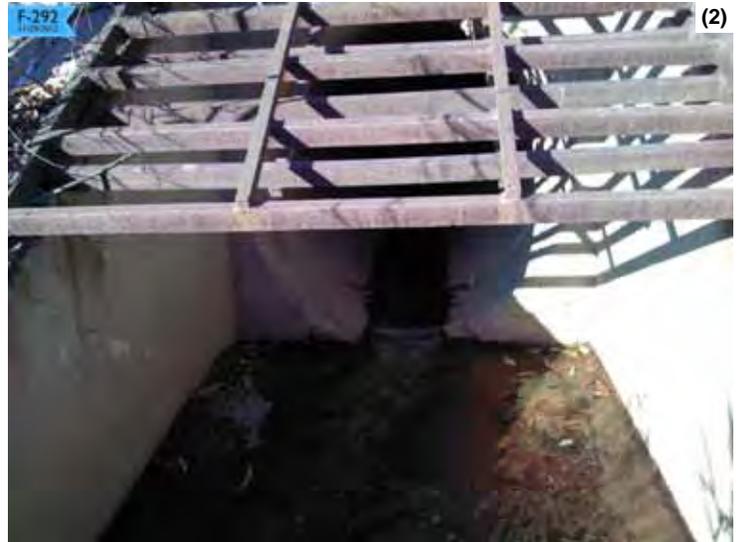
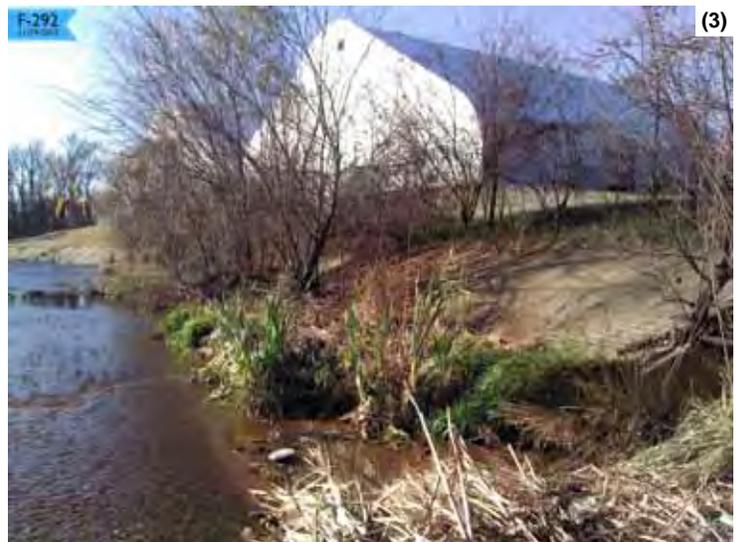
Stream Bank / Pool	<input type="text" value="0"/>	<input type="text" value="Stable"/>	Repairs Recommended? NO
Stream Bank / Pool (x2)	<input type="text" value="0"/>		
Structure	<input type="text" value="1"/>	<input type="text" value="Moderate"/>	
Criticality	<input type="text" value="1"/>	<input type="text" value="Important"/>	
Total Score	<input type="text" value="2"/>	<small>Total = Stream Bank / Pool x2 + Structure + Criticality</small>

Repair security gate.

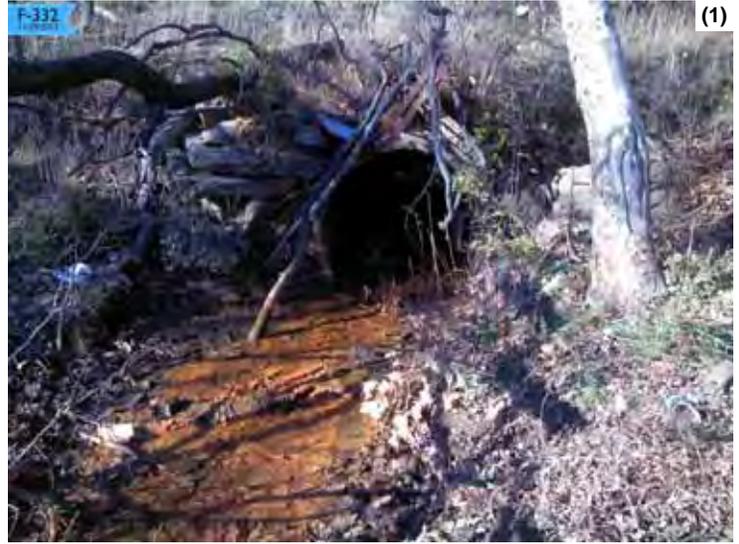
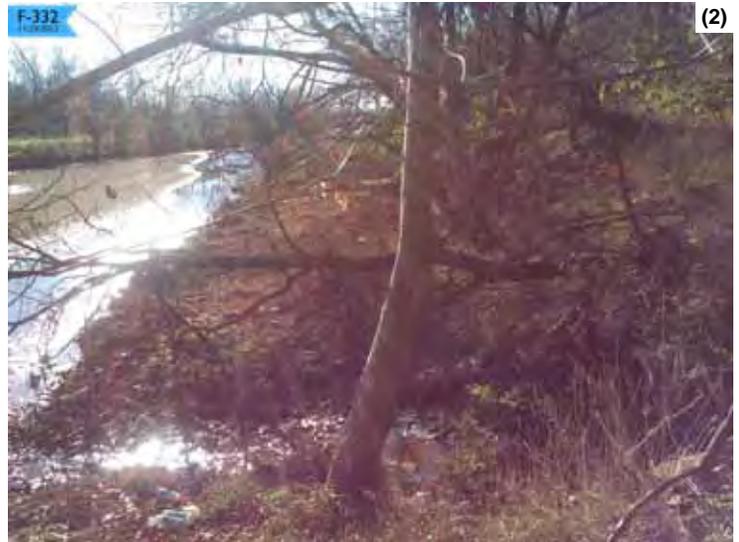
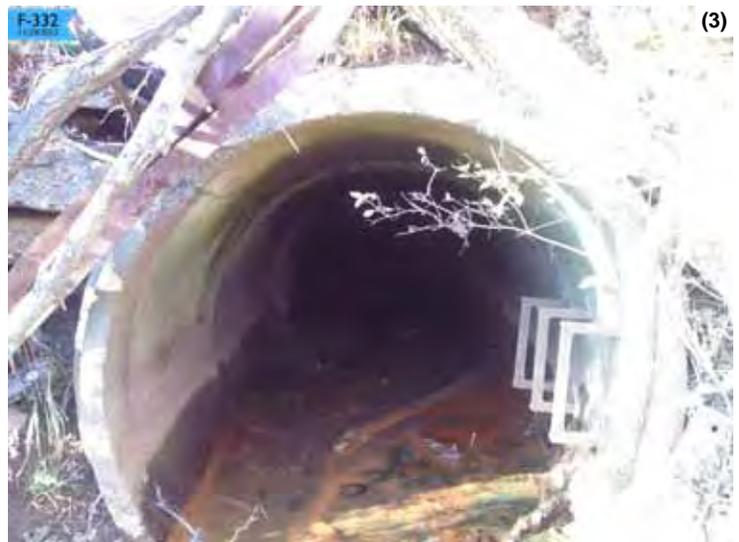
Stream Bank / Pool	<input type="text" value="1"/>	<input type="text" value="Some Erosion"/>	Repairs Recommended? NO
Stream Bank / Pool (x2)	<input type="text" value="2"/>		
Structure	<input type="text" value="0"/>	<input type="text" value="Excellent / Like New"/>	
Criticality	<input type="text" value="0"/>	<input type="text" value="Normal"/>	
Total Score	<input type="text" value="2"/>	<small>Total = Stream Bank / Pool x2 + Structure + Criticality</small>

Unnatural oil sheen with fracturing edges that flows continuously on the surface of water. Odor smells like a mixture of gas and sewage.

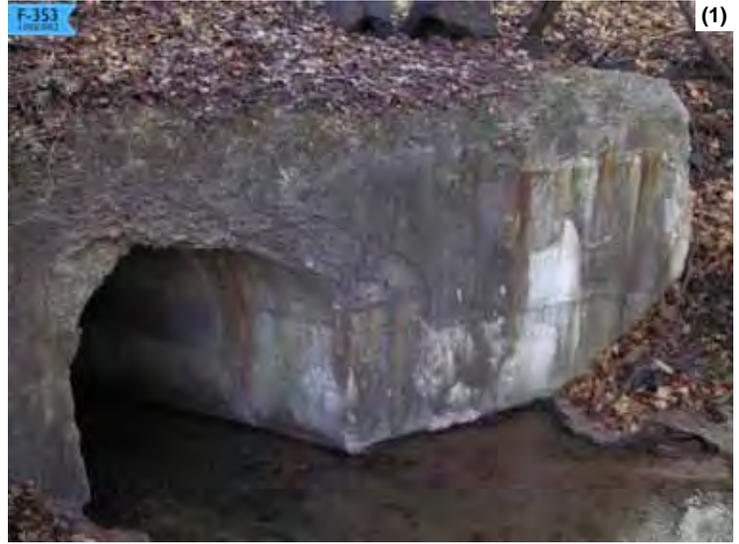
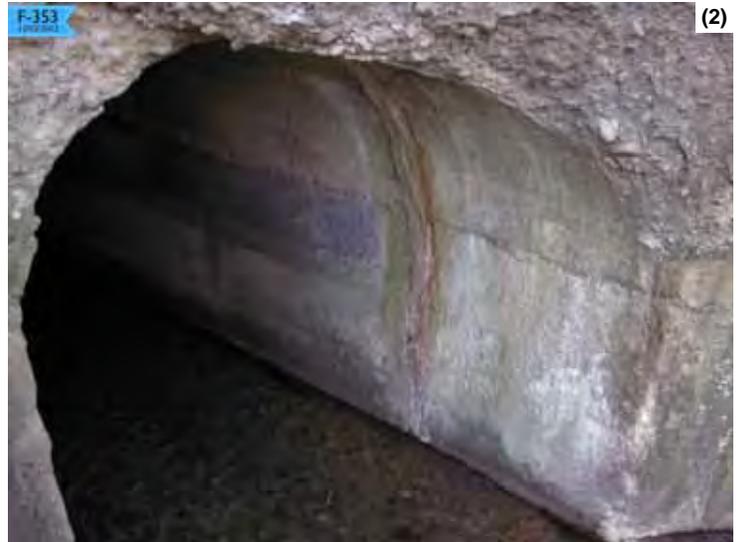
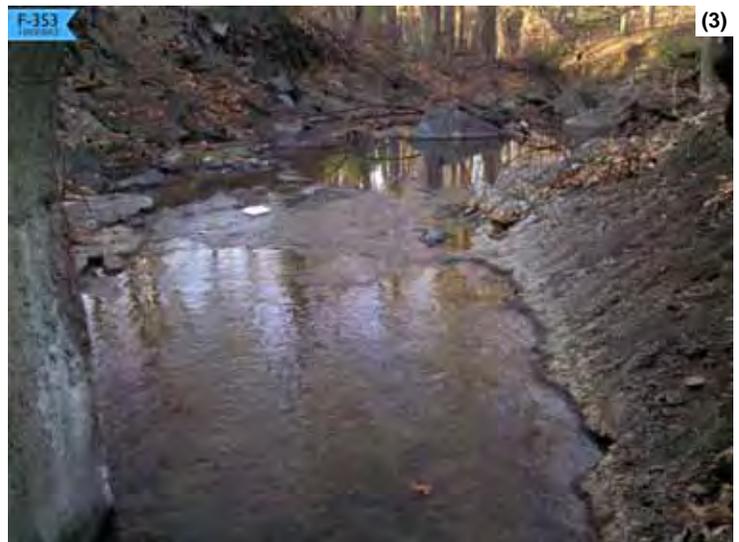
Stream Bank / Pool	<input type="text" value="2"/>	<input type="text" value="Active Erosion"/>	Repairs Recommended? NO
Stream Bank / Pool (x2)	<input type="text" value="4"/>		
Structure	<input type="text" value="0"/>	<input type="text" value="Excellent / Like New"/>	
Criticality	<input type="text" value="0"/>	<input type="text" value="Normal"/>	
Total Score	<input type="text" value="4"/>	<i>Total = Stream Bank / Pool x2 + Structure + Criticality</i>

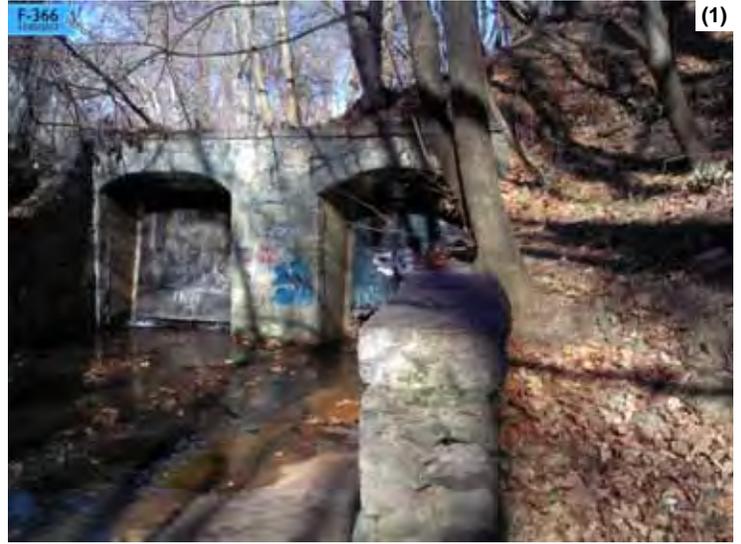
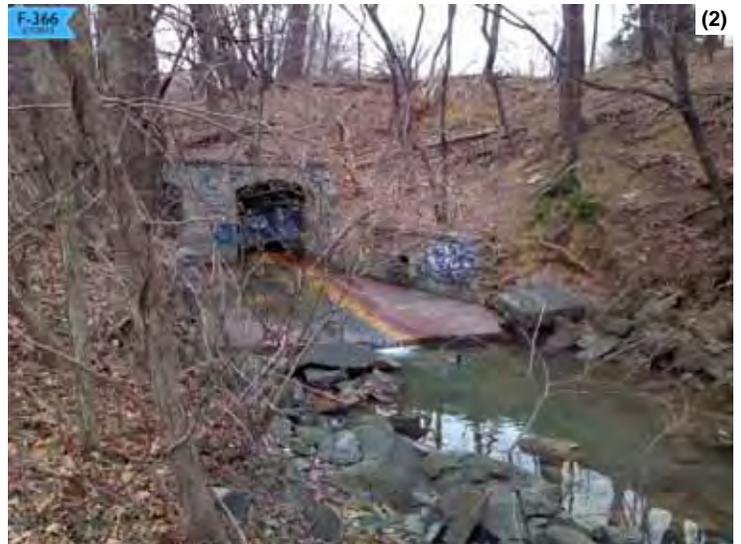
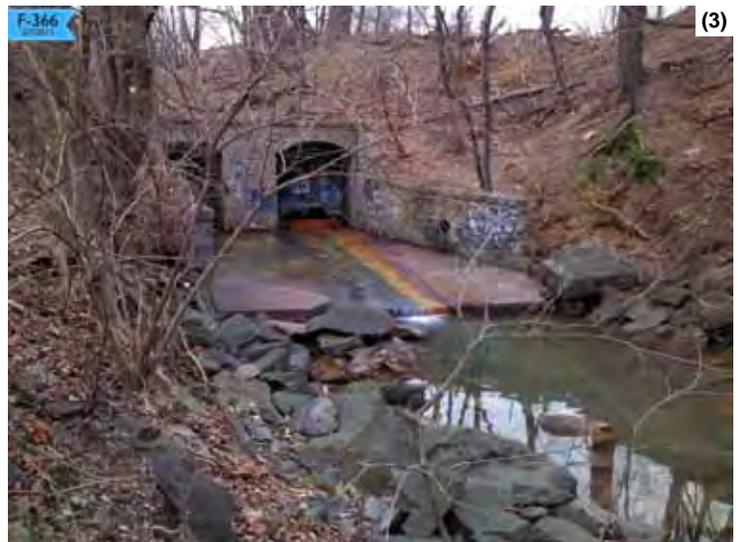
Stream Bank / Pool	<input type="text" value="0"/>	<input type="text" value="Stable"/>	Repairs Recommended? NO
Stream Bank / Pool (x2)	<input type="text" value="0"/>		
Structure	<input type="text" value="1"/>	<input type="text" value="Moderate"/>	
Criticality	<input type="text" value="0"/>	<input type="text" value="Normal"/>	
Total Score	<input type="text" value="1"/>	<small>Total = Stream Bank / Pool x2 + Structure + Criticality</small>

Double outfall (see F-994); broken wingwall (left) and cracked spillway.
