OUTFALL SUMMARY REPORT

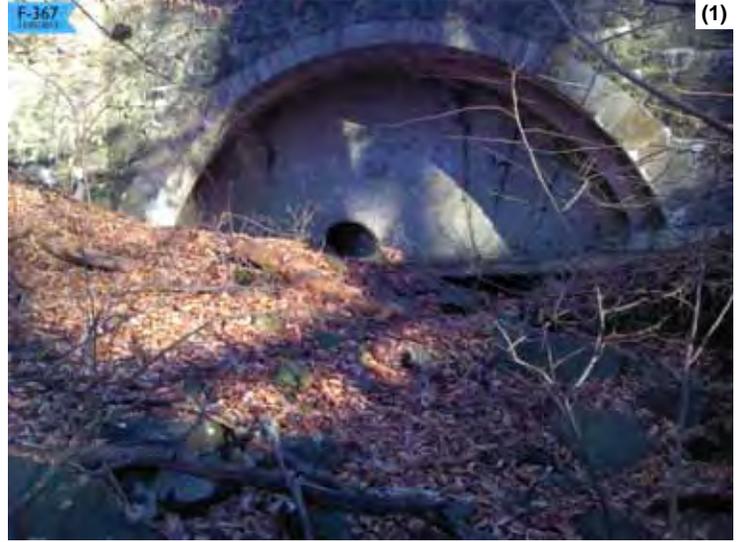
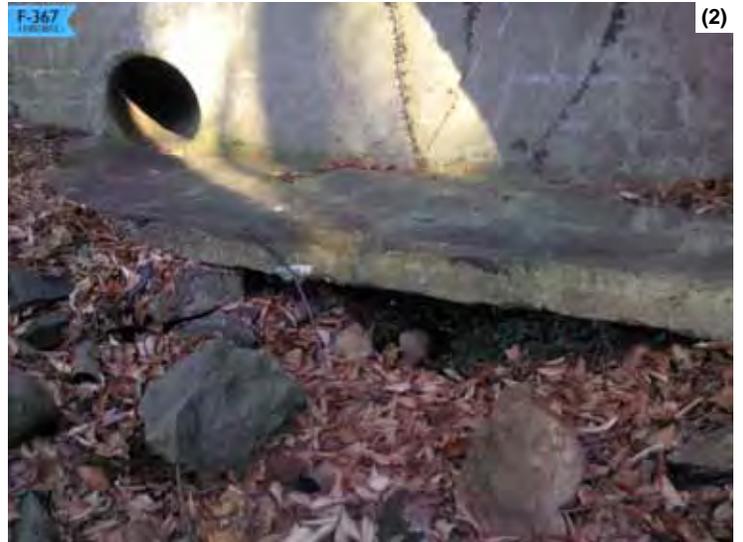
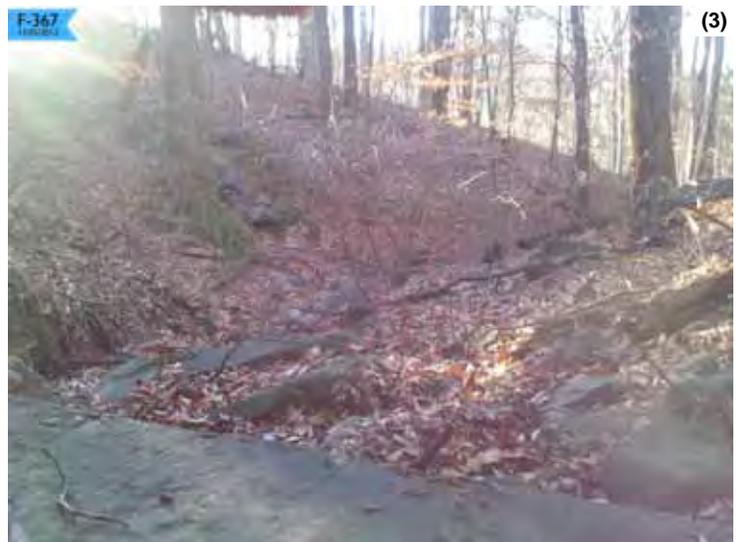
Stream Bank / Pool	<input type="text" value="1"/>	<input type="text" value="Some Erosion"/>	Repairs Recommended? NO
Stream Bank / Pool (x2)	<input type="text" value="2"/>		
Structure	<input type="text" value="1"/>	<input type="text" value="Moderate"/>	
Criticality	<input type="text" value="0"/>	<input type="text" value="Normal"/>	
Total Score	<input type="text" value="3"/>	<small>Total = Stream Bank / Pool x2 + Structure + Criticality</small>

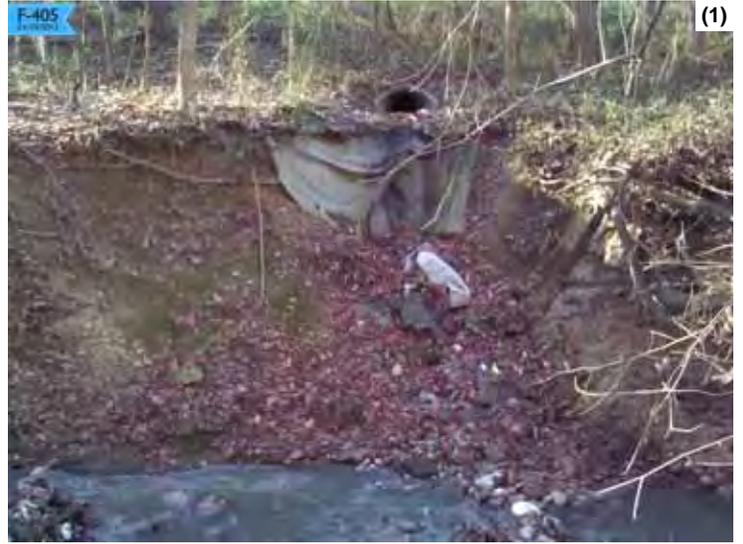
Stream Bank / Pool	<input type="text" value="3"/>	<input type="text" value="Severe Erosion"/>	Repairs Recommended? YES
Stream Bank / Pool (x2)	<input type="text" value="6"/>		
Structure	<input type="text" value="0"/>	<input type="text" value="Excellent / Like New"/>	
Criticality	<input type="text" value="0"/>	<input type="text" value="Normal"/>	
Total Score	<input type="text" value="6"/>	<small>Total = Stream Bank / Pool x2 + Structure + Criticality</small>

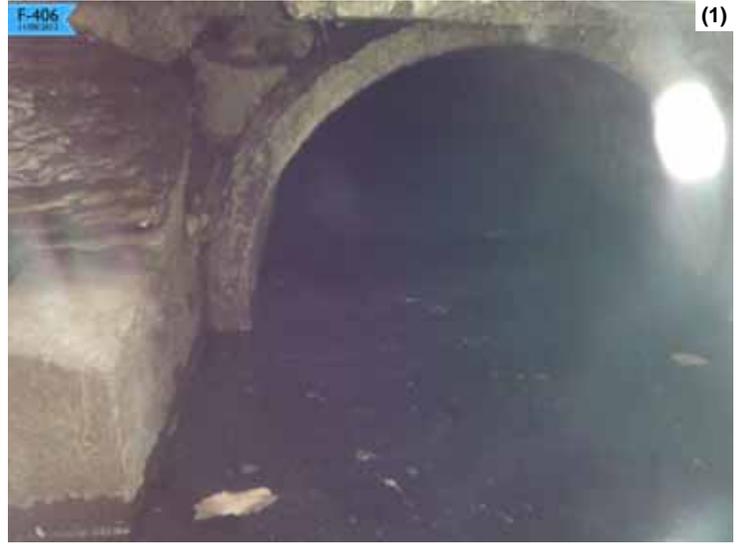
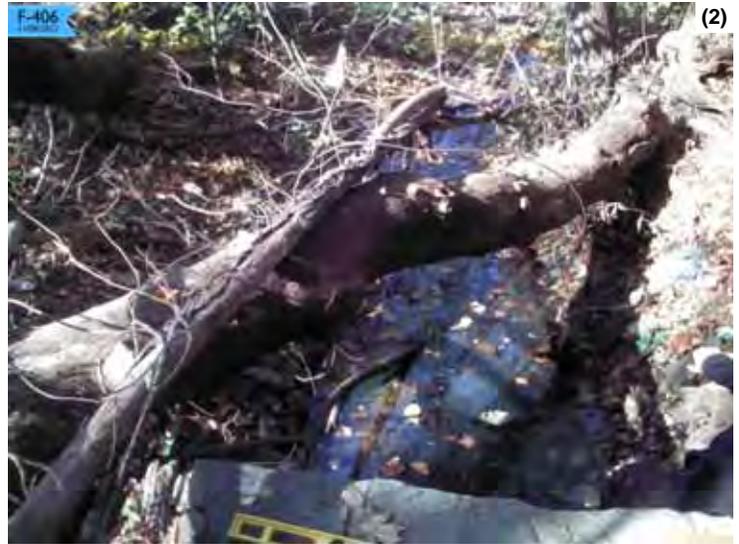
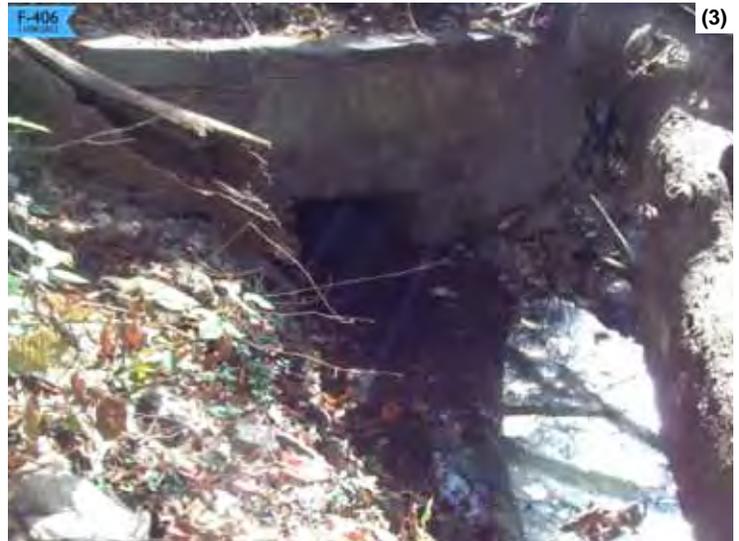
Stream Bank / Pool	<input type="text" value="0"/>	<input type="text" value="Stable"/>	Repairs Recommended? NO
Stream Bank / Pool (x2)	<input type="text" value="0"/>		
Structure	<input type="text" value="1"/>	<input type="text" value="Moderate"/>	
Criticality	<input type="text" value="0"/>	<input type="text" value="Normal"/>	
Total Score	<input type="text" value="1"/>	<small>Total = Stream Bank / Pool x2 + Structure + Criticality</small>

Deteriorated headwall left corner.

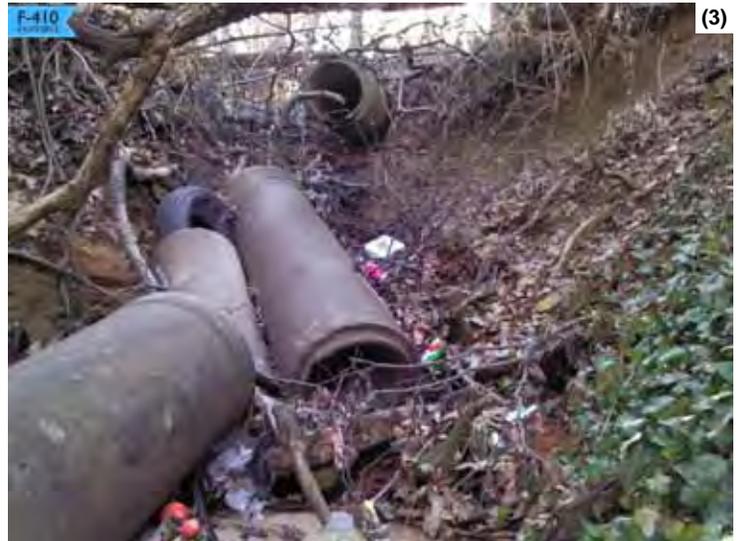
Stream Bank / Pool	<input type="text" value="3"/>	<input type="text" value="Severe Erosion"/>	Repairs Recommended? YES
Stream Bank / Pool (x2)	<input type="text" value="6"/>		
Structure	<input type="text" value="3"/>	<input type="text" value="Very Poor"/>	
Criticality	<input type="text" value="0"/>	<input type="text" value="Normal"/>	
Total Score	<input type="text" value="9"/>	<small>Total = Stream Bank / Pool x2 + Structure + Criticality</small>

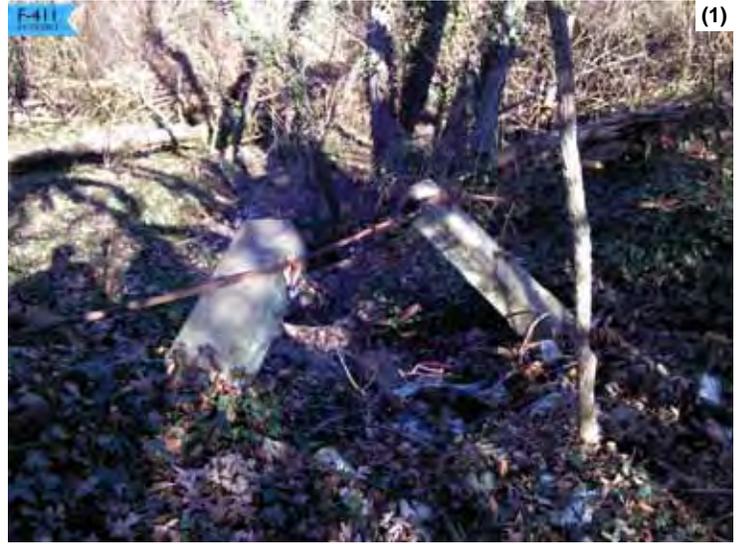
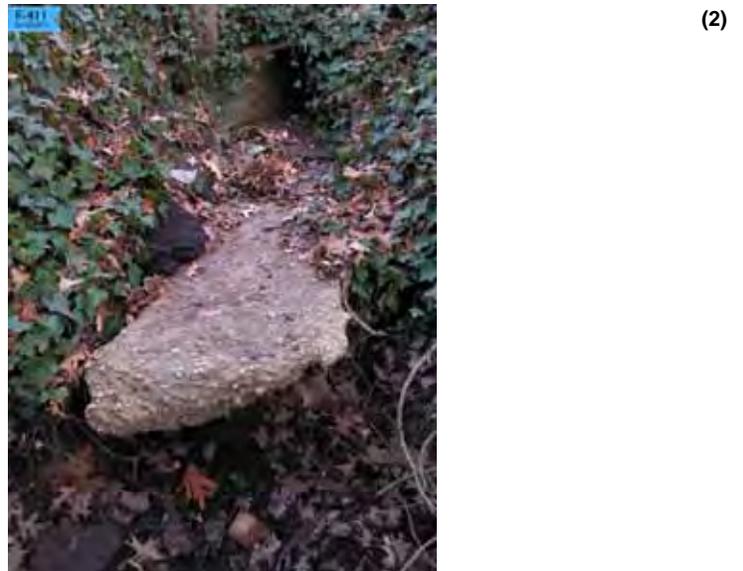
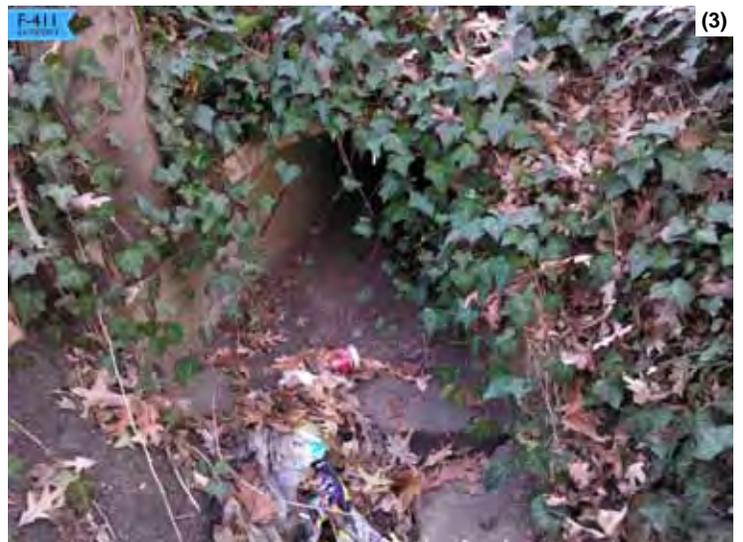
Stream Bank / Pool	<input type="text" value="1"/>	<input type="text" value="Some Erosion"/>	Repairs Recommended? NO
Stream Bank / Pool (x2)	<input type="text" value="2"/>		
Structure	<input type="text" value="1"/>	<input type="text" value="Moderate"/>	
Criticality	<input type="text" value="0"/>	<input type="text" value="Normal"/>	
Total Score	<input type="text" value="3"/>	<small>Total = Stream Bank / Pool x2 + Structure + Criticality</small>

Splash pad broken off. Some downstream erosion

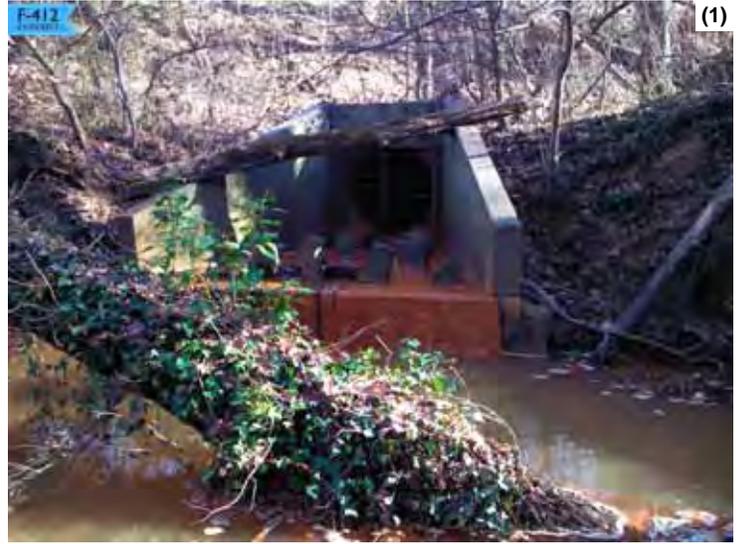
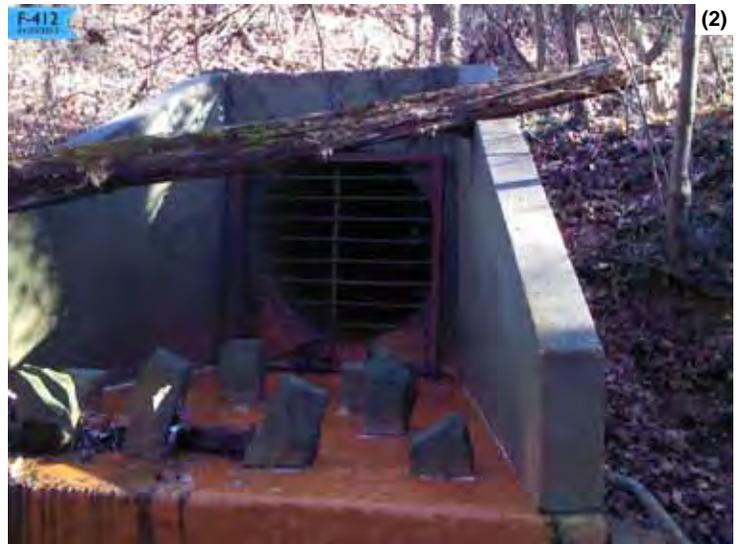
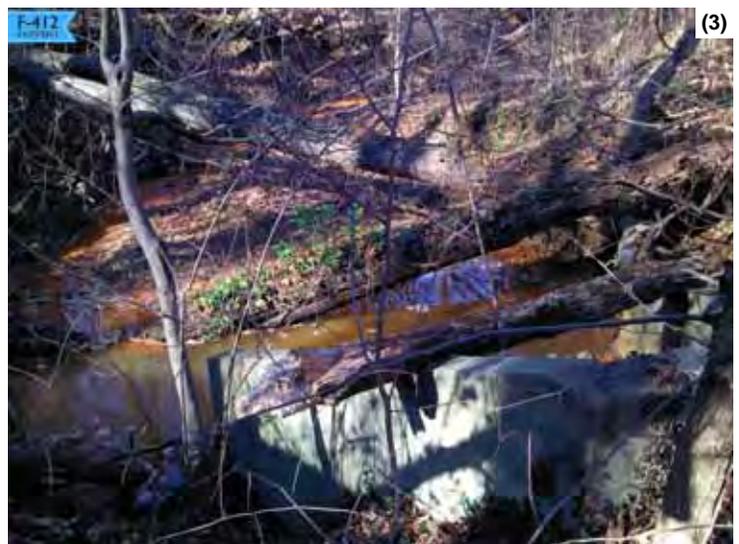
Stream Bank / Pool	<input type="text" value="2"/>	<input type="text" value="Active Erosion"/>	Repairs Recommended? YES
Stream Bank / Pool (x2)	<input type="text" value="4"/>		
Structure	<input type="text" value="0"/>	<input type="text" value="Excellent / Like New"/>	
Criticality	<input type="text" value="0"/>	<input type="text" value="Normal"/>	
Total Score	<input type="text" value="4"/>	<small>Total = Stream Bank / Pool x2 + Structure + Criticality</small>

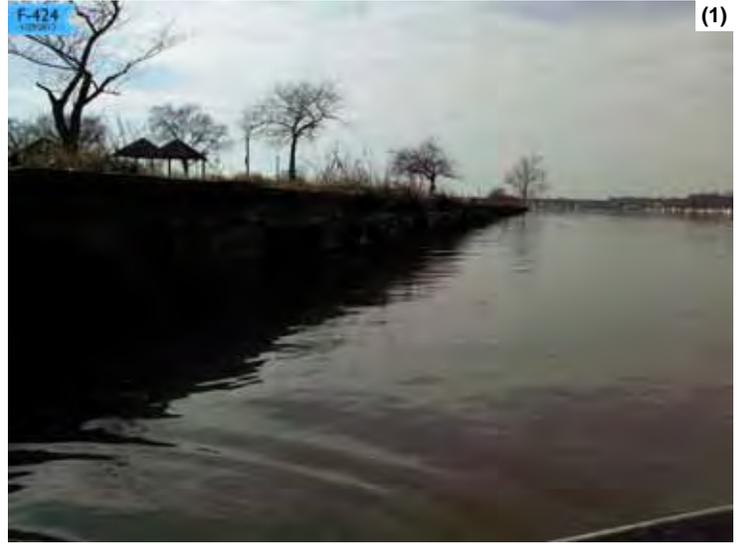
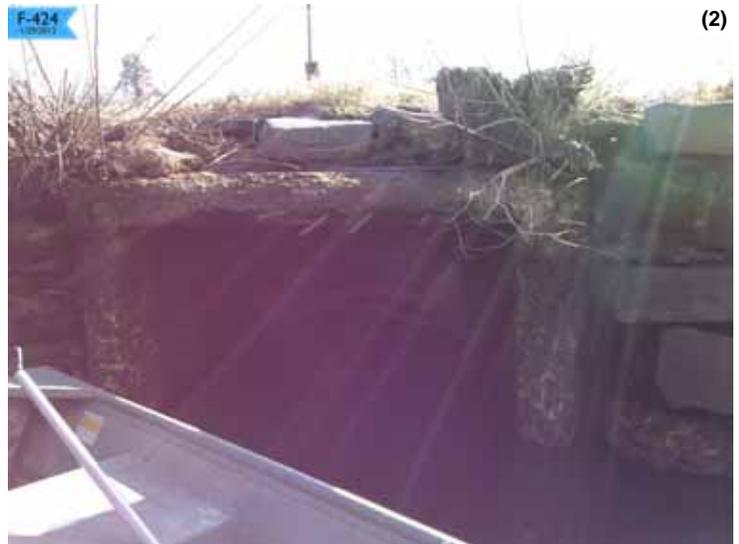
Flap gate broken off.

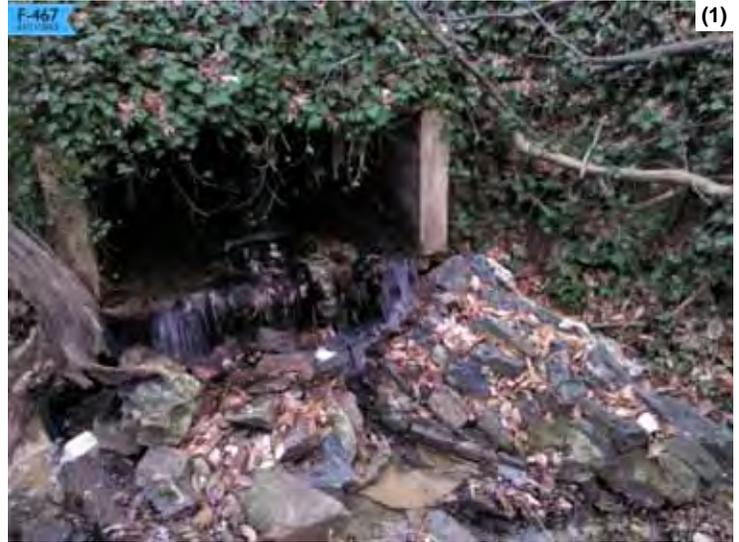
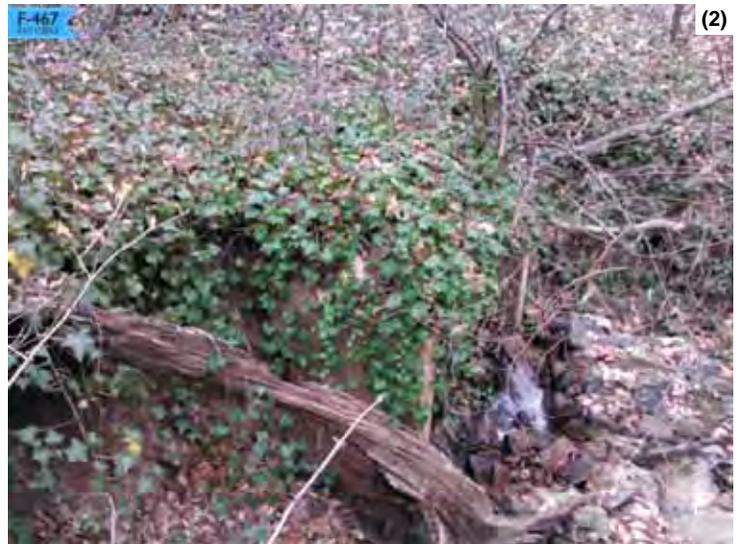
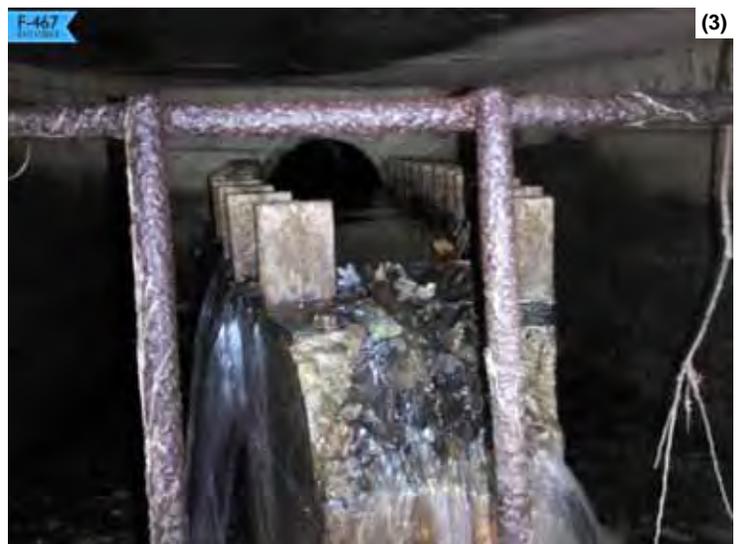
Stream Bank / Pool	<input type="text" value="3"/>	<input type="text" value="Severe Erosion"/>	Repairs Recommended? YES
Stream Bank / Pool (x2)	<input type="text" value="6"/>		
Structure	<input type="text" value="1"/>	<input type="text" value="Moderate"/>	
Criticality	<input type="text" value="0"/>	<input type="text" value="Normal"/>	
Total Score	<input type="text" value="7"/>	<small>Total = Stream Bank / Pool x2 + Structure + Criticality</small>

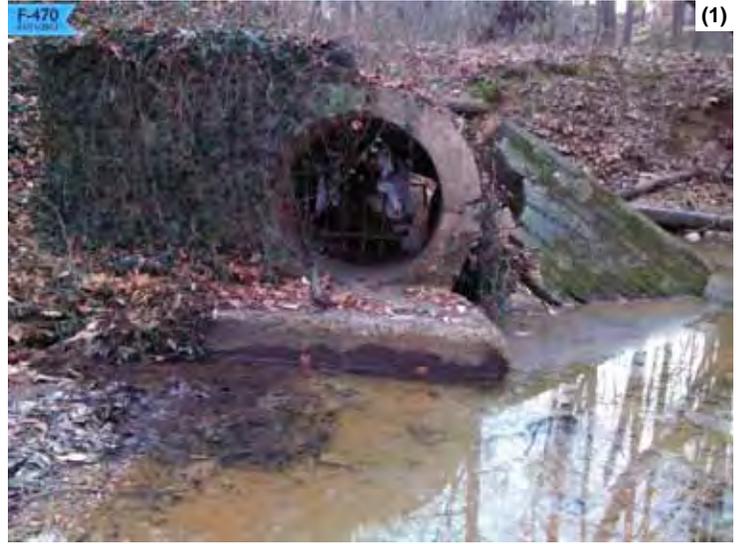
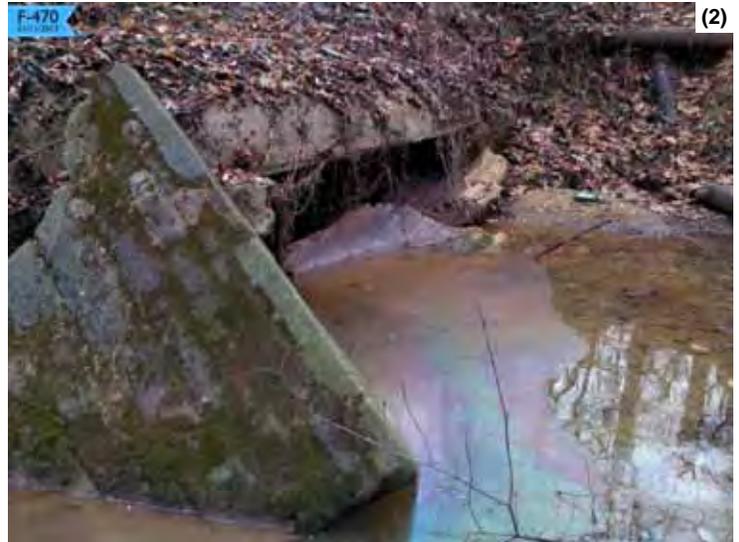
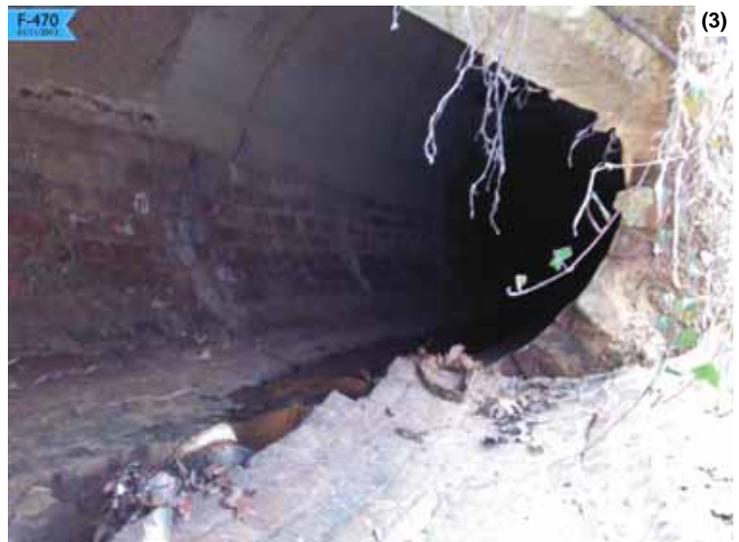
Stream Bank / Pool	<input type="text" value="3"/>	<input type="text" value="Severe Erosion"/>	Repairs Recommended? YES
Stream Bank / Pool (x2)	<input type="text" value="6"/>		
Structure	<input type="text" value="2"/>	<input type="text" value="Poor"/>	
Criticality	<input type="text" value="0"/>	<input type="text" value="Normal"/>	
Total Score	<input type="text" value="8"/>	<i>Total = Stream Bank / Pool x2 + Structure + Criticality</i>

Headwall partially collapsed. Pipe behind head wall is broken and collapsed. Severe upstream/downstream erosion.

Point Repair

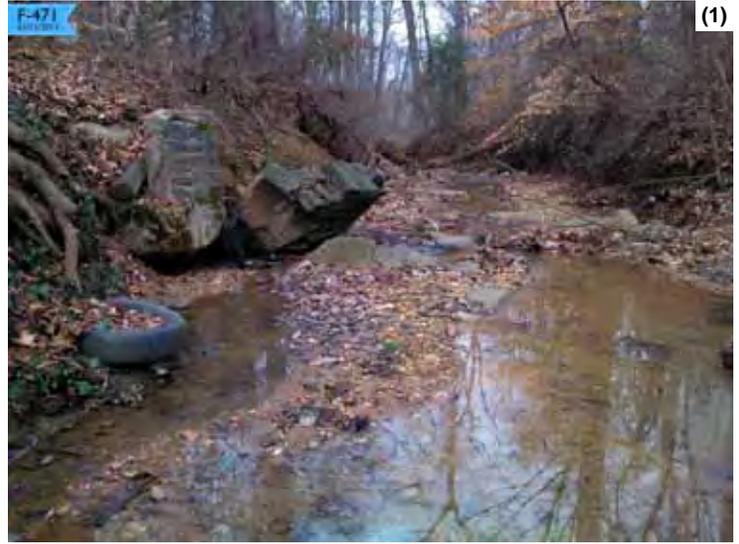
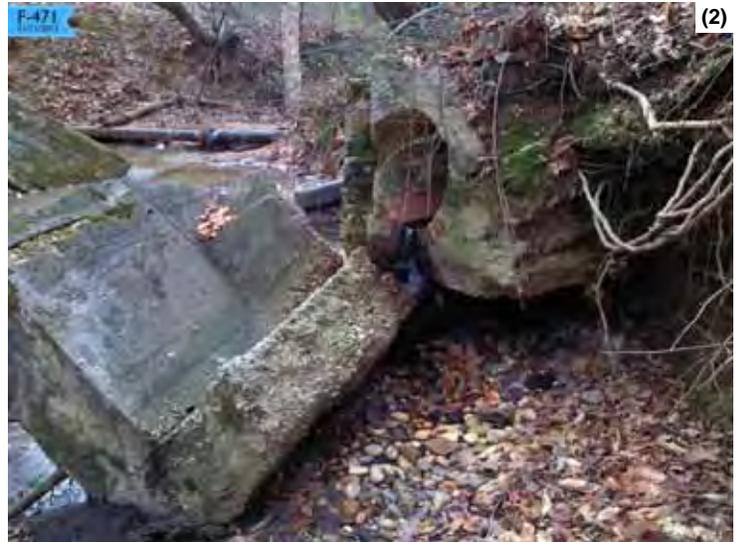
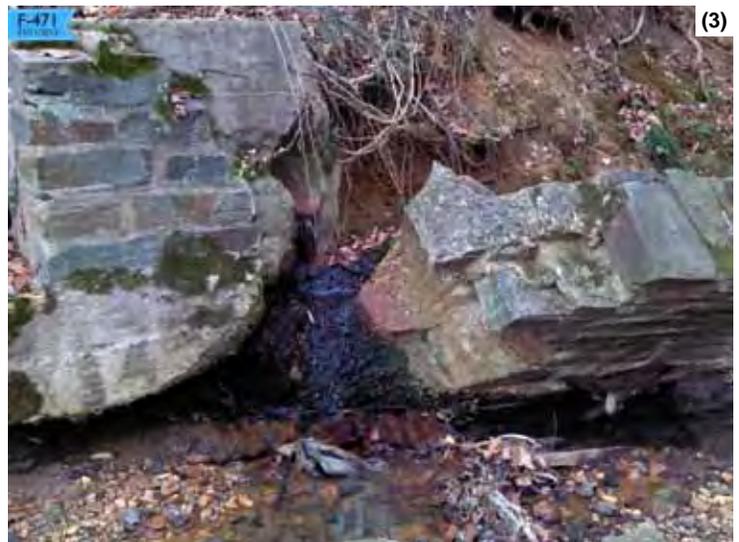
Stream Bank / Pool	<input type="text" value="3"/>	<input type="text" value="Severe Erosion"/>	Repairs Recommended? YES
Stream Bank / Pool (x2)	<input type="text" value="6"/>		
Structure	<input type="text" value="2"/>	<input type="text" value="Poor"/>	
Criticality	<input type="text" value="0"/>	<input type="text" value="Normal"/>	
Total Score	<input type="text" value="8"/>	<small>Total = Stream Bank / Pool x2 + Structure + Criticality</small>

Point Repair

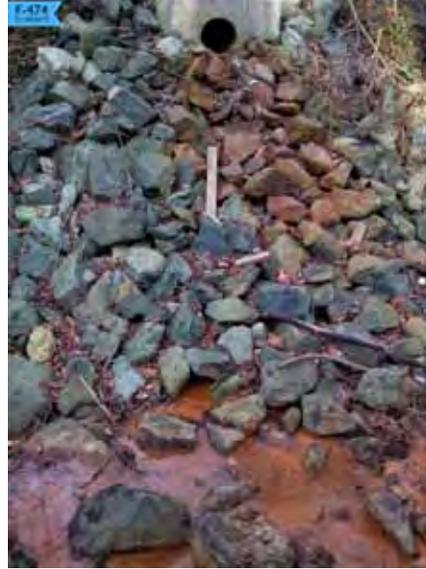
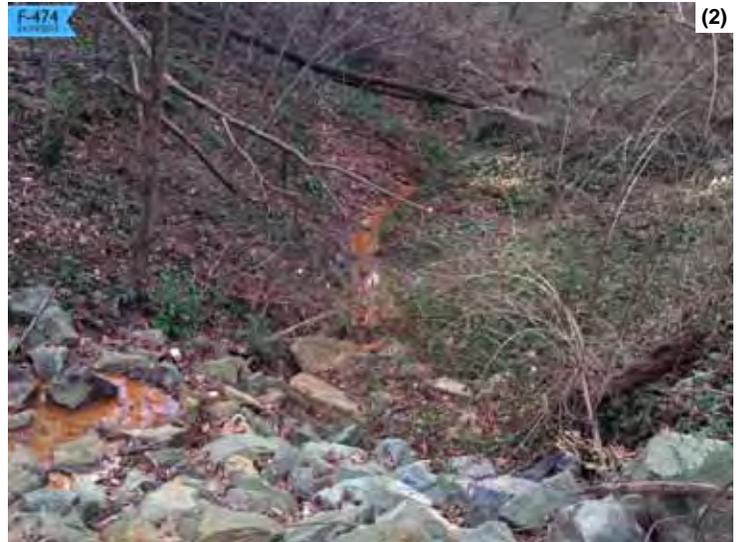
Stream Bank / Pool	<input type="text" value="2"/>	<input type="text" value="Active Erosion"/>	Repairs Recommended? NO
Stream Bank / Pool (x2)	<input type="text" value="4"/>		
Structure	<input type="text" value="0"/>	<input type="text" value="Excellent / Like New"/>	
Criticality	<input type="text" value="0"/>	<input type="text" value="Normal"/>	
Total Score	<input type="text" value="4"/>	<small>Total = Stream Bank / Pool x2 + Structure + Criticality</small>

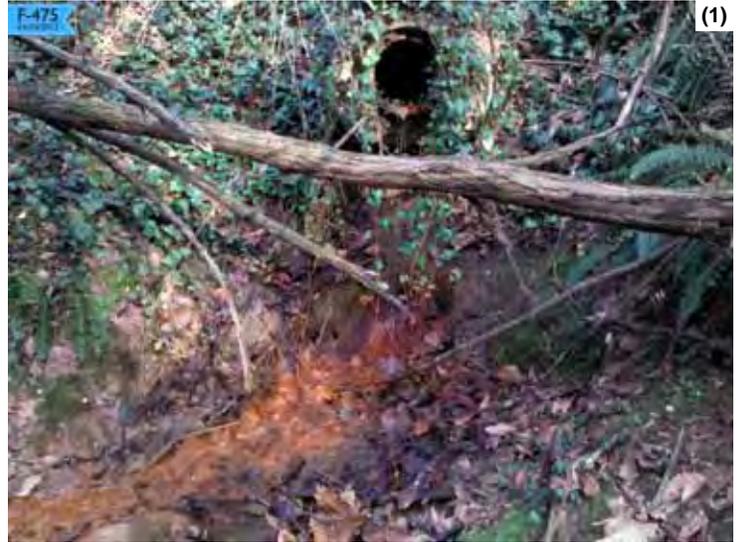
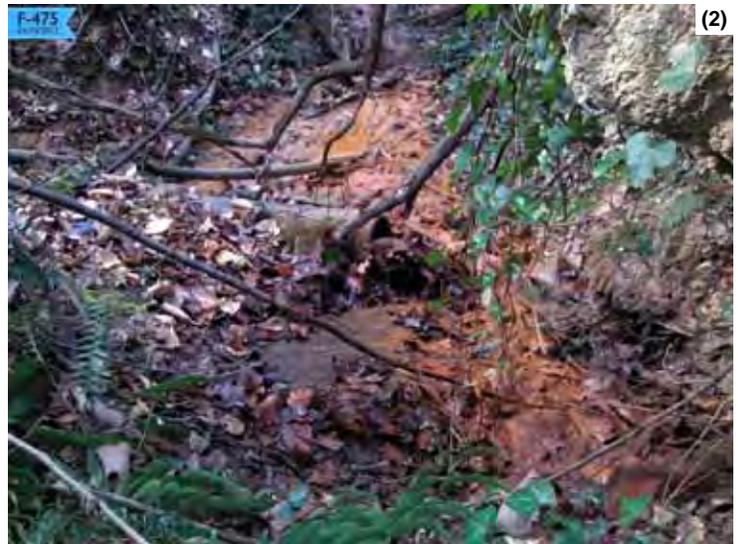
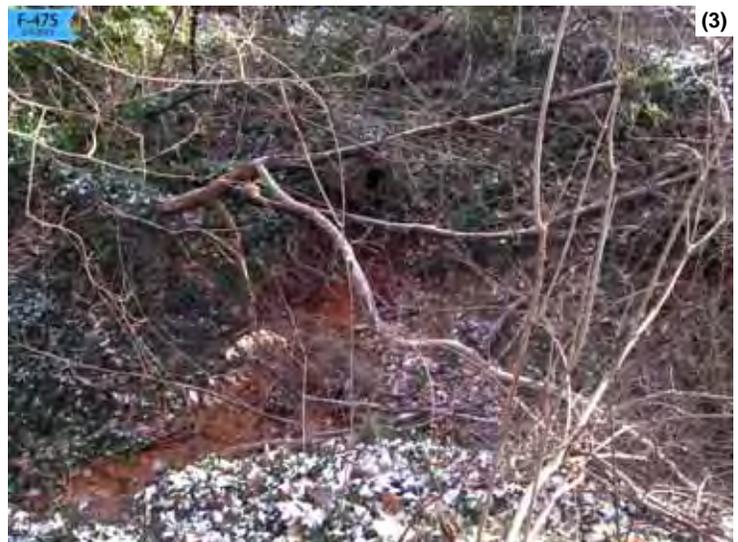
Stream Bank / Pool	<input type="text" value="3"/>	<input type="text" value="Severe Erosion"/>	Repairs Recommended? YES
Stream Bank / Pool (x2)	<input type="text" value="6"/>		
Structure	<input type="text" value="3"/>	<input type="text" value="Very Poor"/>	
Criticality	<input type="text" value="0"/>	<input type="text" value="Normal"/>	
Total Score	<input type="text" value="9"/>	<small>Total = Stream Bank / Pool x2 + Structure + Criticality</small>

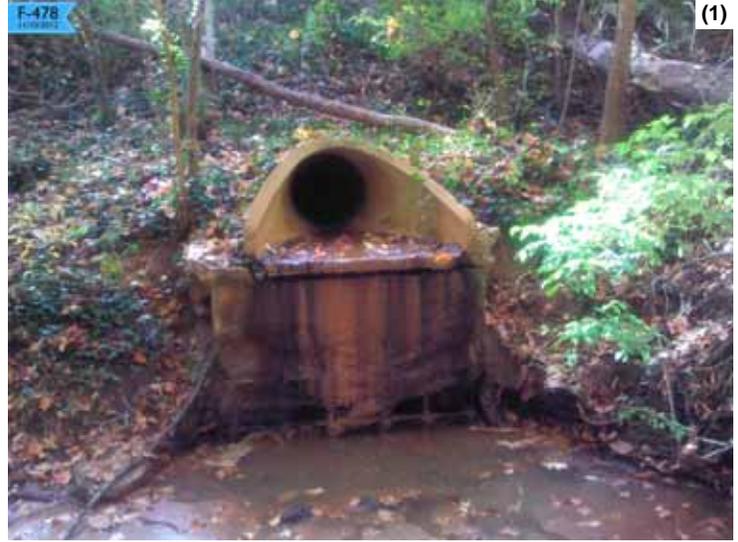
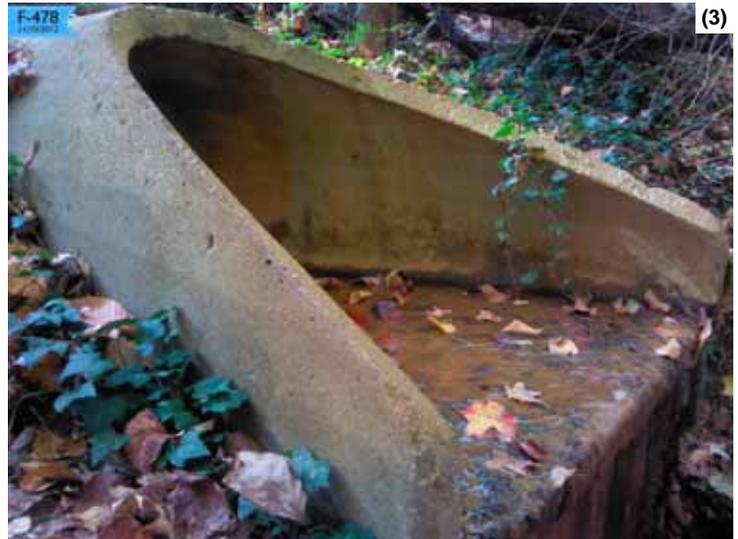
Stream Bank / Pool	<input type="text" value="2"/>	<input type="text" value="Active Erosion"/>	Repairs Recommended? NO
Stream Bank / Pool (x2)	<input type="text" value="4"/>		
Structure	<input type="text" value="1"/>	<input type="text" value="Moderate"/>	
Criticality	<input type="text" value="0"/>	<input type="text" value="Normal"/>	
Total Score	<input type="text" value="5"/>	<small>Total = Stream Bank / Pool x2 + Structure + Criticality</small>

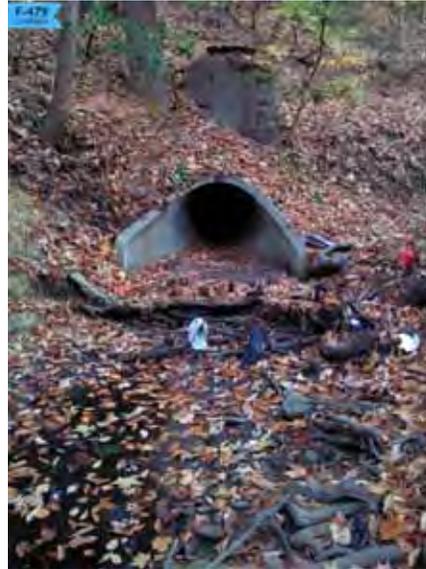
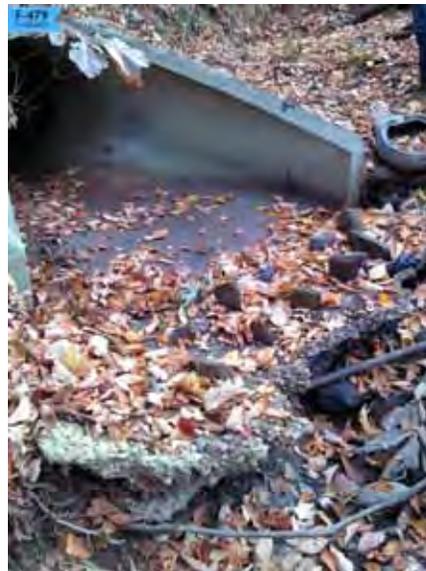
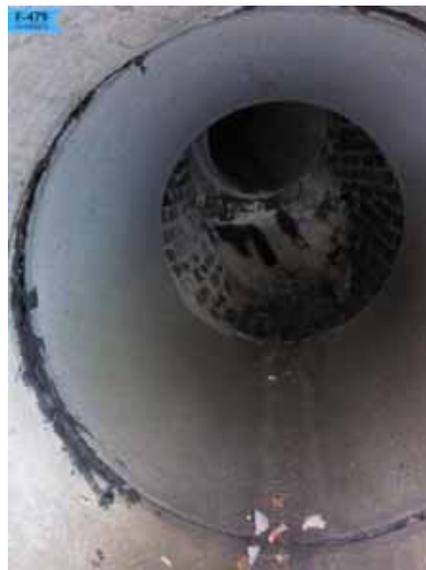
Stream Bank / Pool	<input type="text" value="1"/>	<input type="text" value="Some Erosion"/>	Repairs Recommended? NO
Stream Bank / Pool (x2)	<input type="text" value="2"/>		
Structure	<input type="text" value="1"/>	<input type="text" value="Moderate"/>	
Criticality	<input type="text" value="0"/>	<input type="text" value="Normal"/>	
Total Score	<input type="text" value="3"/>	<small>Total = Stream Bank / Pool x2 + Structure + Criticality</small>

Minor erosion and reinforcement spalling at Flared End Section (FES). First pipe joint is offset and open.

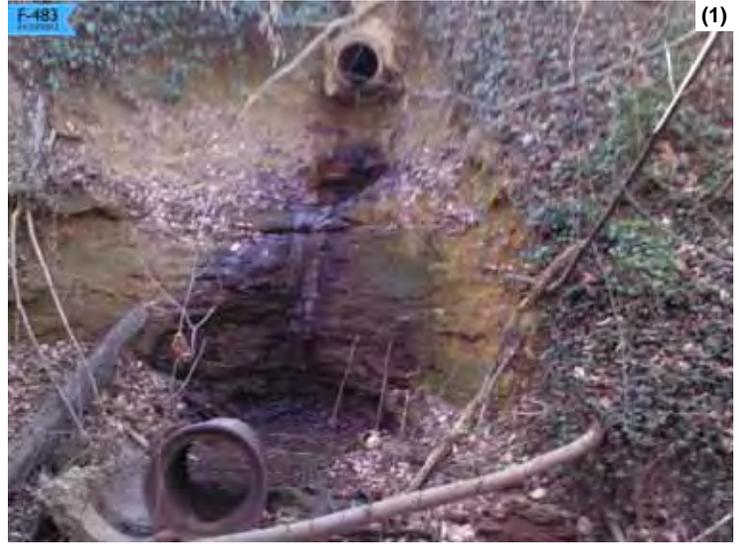
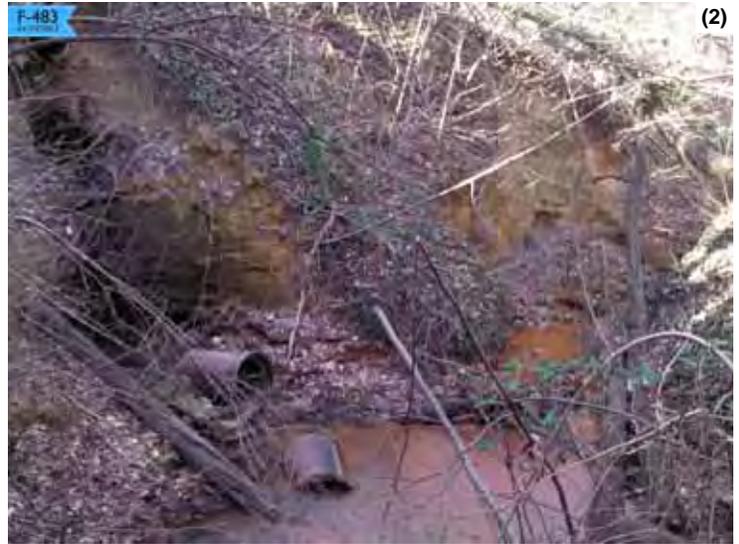
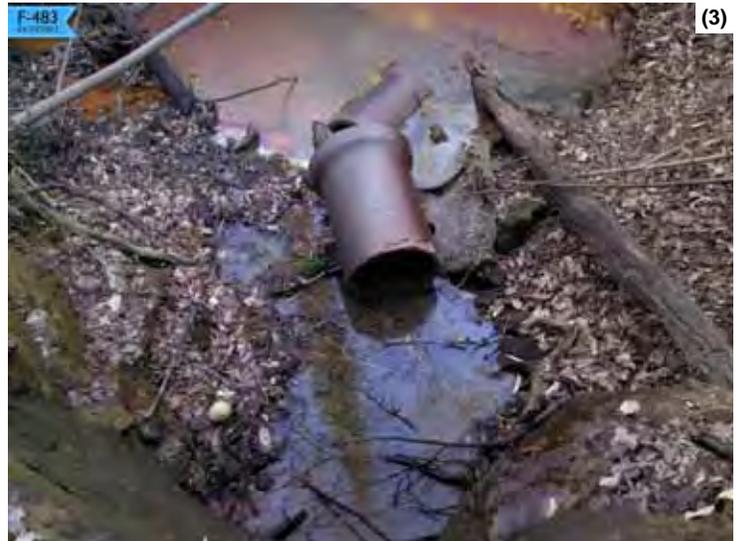
Stream Bank / Pool	<input type="text" value="3"/>	<input type="text" value="Severe Erosion"/>	Repairs Recommended? YES
Stream Bank / Pool (x2)	<input type="text" value="6"/>		
Structure	<input type="text" value="3"/>	<input type="text" value="Very Poor"/>	
Criticality	<input type="text" value="0"/>	<input type="text" value="Normal"/>	
Total Score	<input type="text" value="9"/>	<i>Total = Stream Bank / Pool x2 + Structure + Criticality</i>

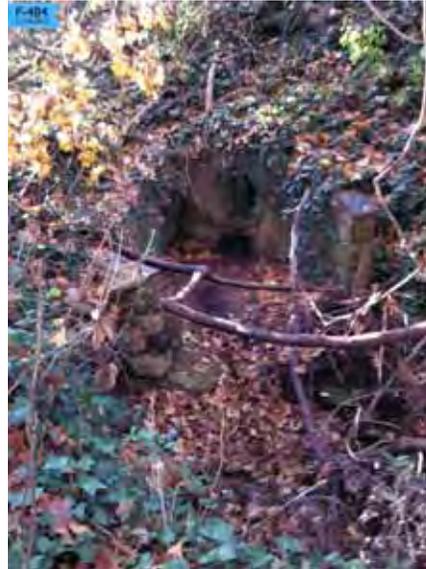
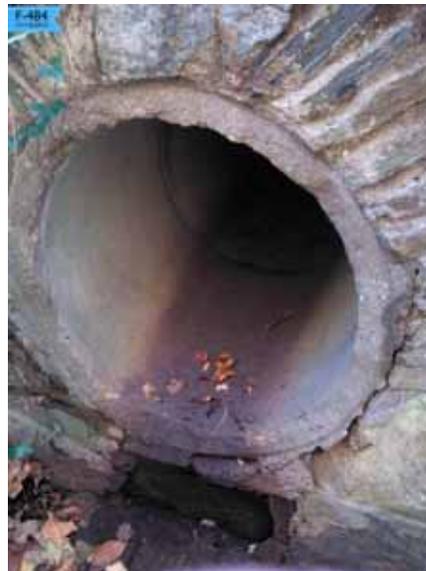
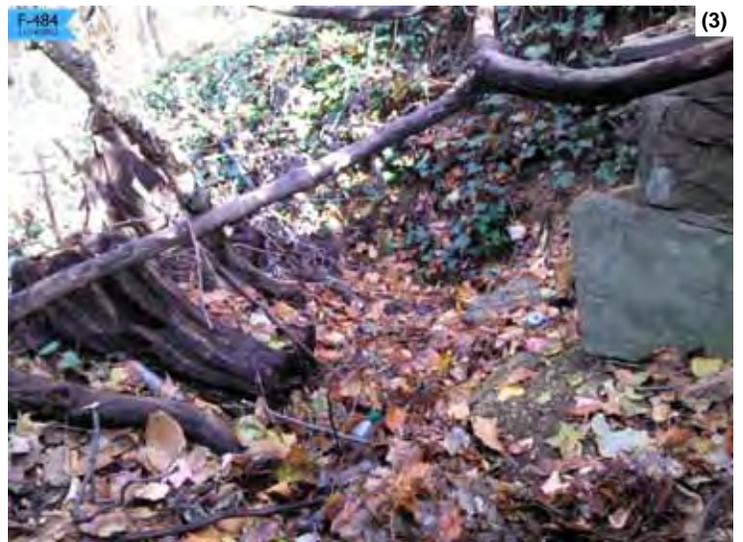
Stream Bank / Pool	<input type="text" value="1"/>	<input type="text" value="Some Erosion"/>	Repairs Recommended? NO
Stream Bank / Pool (x2)	<input type="text" value="2"/>		
Structure	<input type="text" value="1"/>	<input type="text" value="Moderate"/>	
Criticality	<input type="text" value="0"/>	<input type="text" value="Normal"/>	
Total Score	<input type="text" value="3"/>	<small>Total = Stream Bank / Pool x2 + Structure + Criticality</small>

Minor cracks in headwall and minor erosion below spillway.

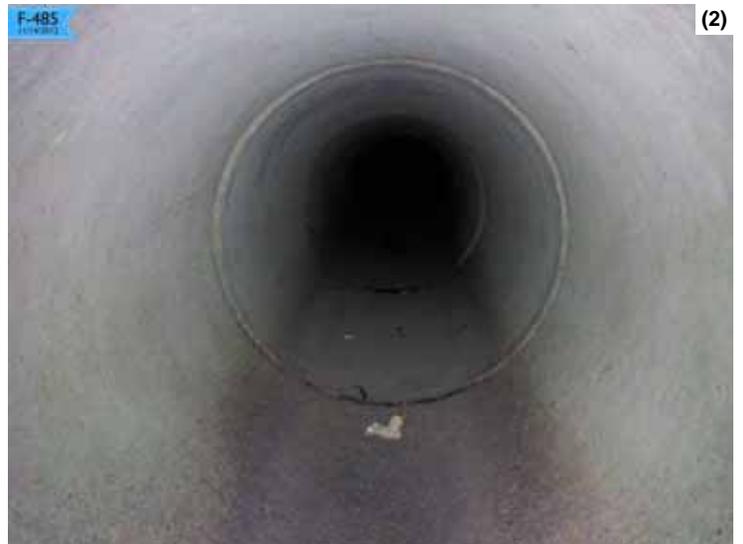
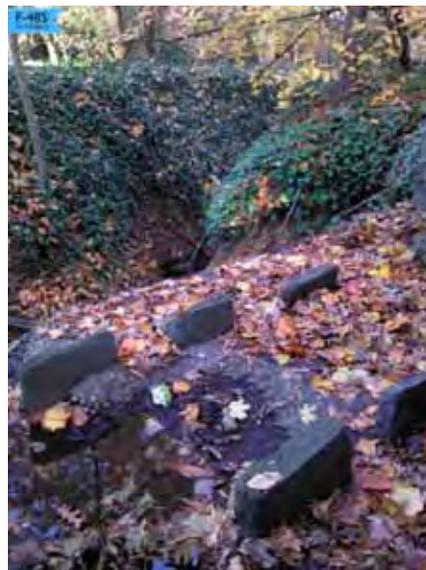
Stream Bank / Pool	<input type="text" value="3"/>	<input type="text" value="Severe Erosion"/>	Repairs Recommended? YES
Stream Bank / Pool (x2)	<input type="text" value="6"/>		
Structure	<input type="text" value="2"/>	<input type="text" value="Poor"/>	
Criticality	<input type="text" value="0"/>	<input type="text" value="Normal"/>	
Total Score	<input type="text" value="8"/>	<small>Total = Stream Bank / Pool x2 + Structure + Criticality</small>

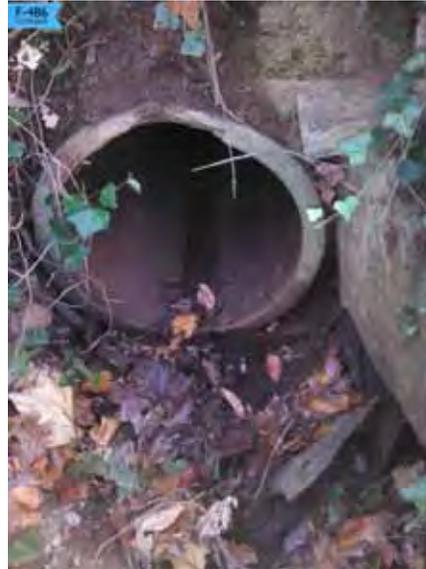
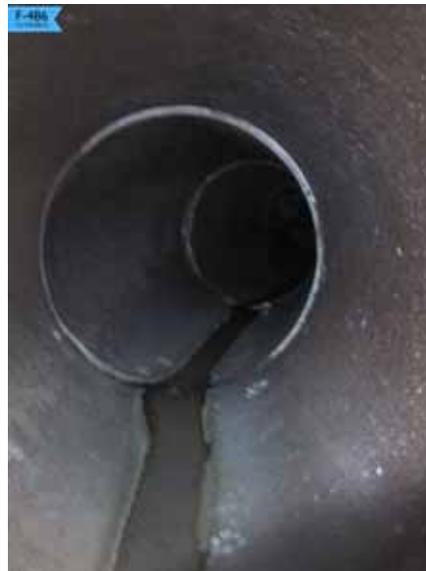
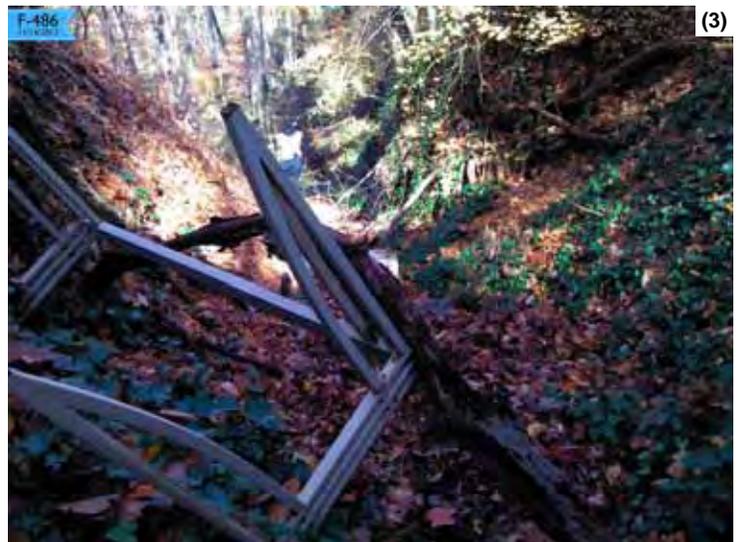
Repairs Recommended?
YES

Pipe and headwall may be found in downstream channel. Severe downstream gully erosion.

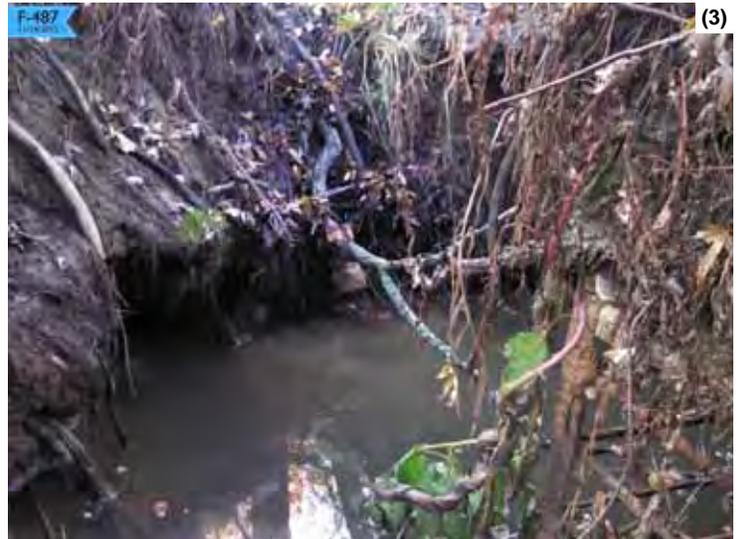
Stream Bank / Pool	<input type="text" value="1"/>	<input type="text" value="Some Erosion"/>	Repairs Recommended? YES
Stream Bank / Pool (x2)	<input type="text" value="2"/>		
Structure	<input type="text" value="2"/>	<input type="text" value="Poor"/>	
Criticality	<input type="text" value="0"/>	<input type="text" value="Normal"/>	
Total Score	<input type="text" value="4"/>	<small>Total = Stream Bank / Pool x2 + Structure + Criticality</small>

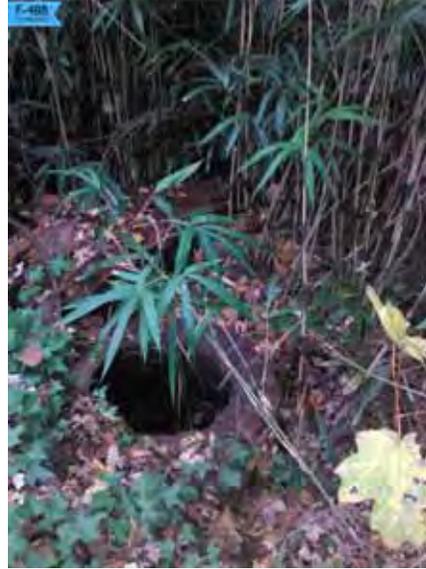
Stream Bank / Pool	<input type="text" value="0"/>	<input type="text" value="Stable"/>	Repairs Recommended? YES
Stream Bank / Pool (x2)	<input type="text" value="0"/>		
Structure	<input type="text" value="2"/>	<input type="text" value="Poor"/>	
Criticality	<input type="text" value="0"/>	<input type="text" value="Normal"/>	
Total Score	<input type="text" value="2"/>	<small>Total = Stream Bank / Pool x2 + Structure + Criticality</small>

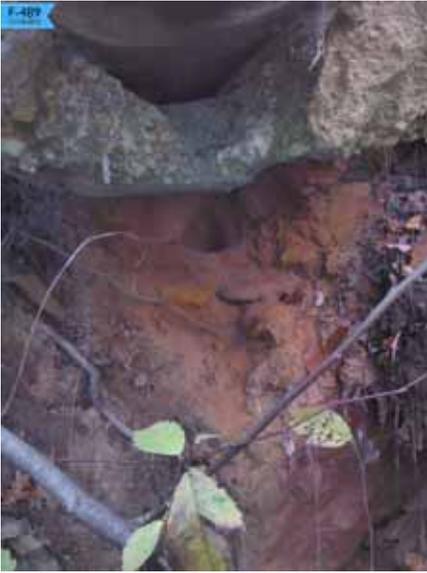
(4)

Stream Bank / Pool	<input type="text" value="2"/>	<input type="text" value="Active Erosion"/>	Repairs Recommended? YES
Stream Bank / Pool (x2)	<input type="text" value="4"/>		
Structure	<input type="text" value="2"/>	<input type="text" value="Poor"/>	
Criticality	<input type="text" value="0"/>	<input type="text" value="Normal"/>	
Total Score	<input type="text" value="6"/>	<i>Total = Stream Bank / Pool x2 + Structure + Criticality</i>

Severe erosion upstream, under pipe and downstream. Broken off headwall may be located under logs/brush pile.

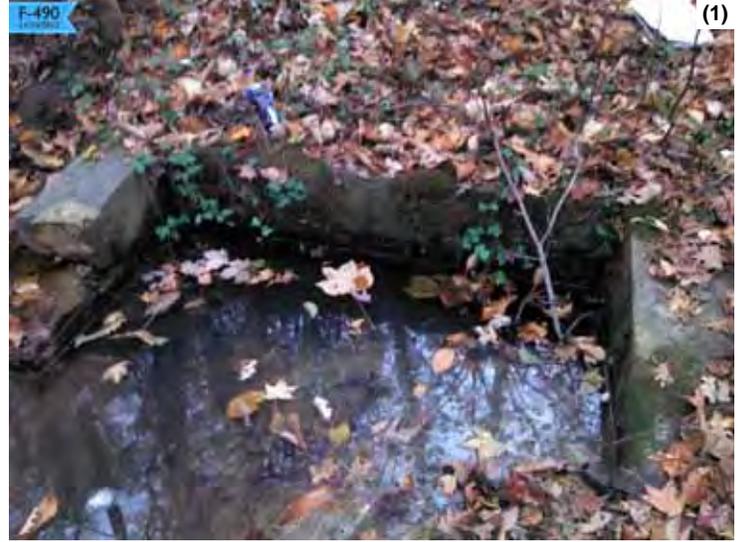
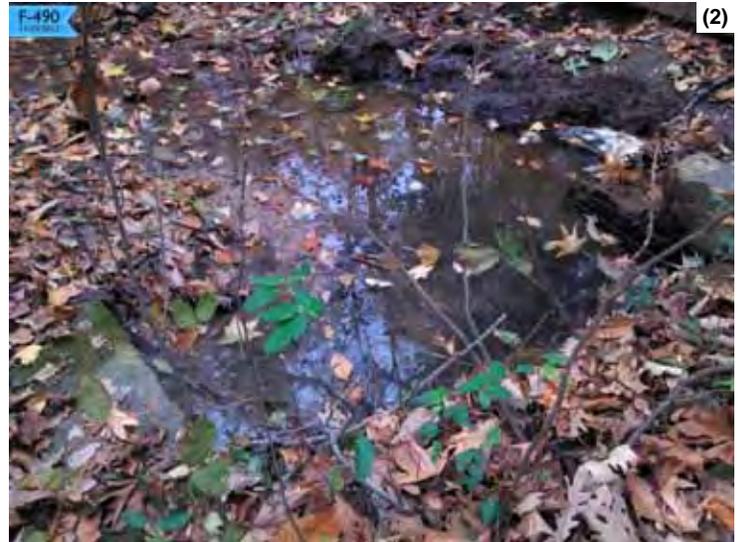
Stream Bank / Pool	<input type="text" value="0"/>	<input type="text" value="Stable"/>	Repairs Recommended? NO
Stream Bank / Pool (x2)	<input type="text" value="0"/>		
Structure	<input type="text" value="1"/>	<input type="text" value="Moderate"/>	
Criticality	<input type="text" value="0"/>	<input type="text" value="Normal"/>	
Total Score	<input type="text" value="1"/>	<small>Total = Stream Bank / Pool x2 + Structure + Criticality</small>

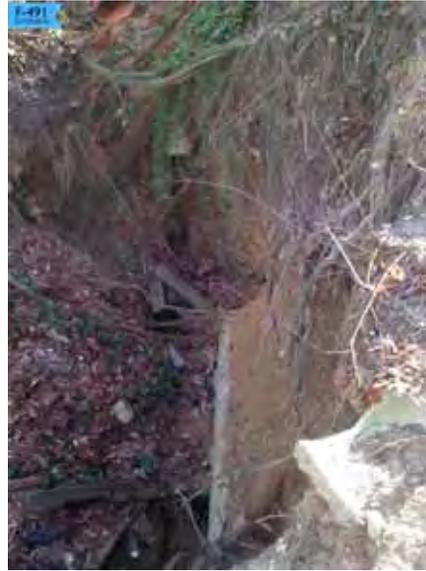
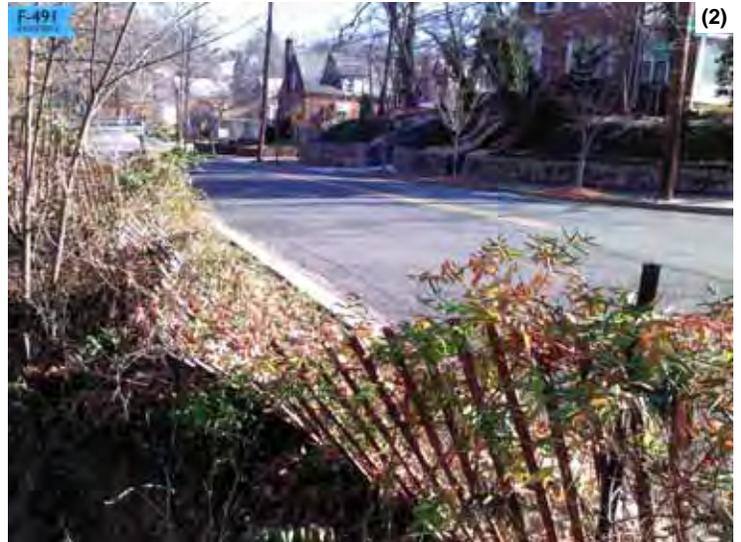
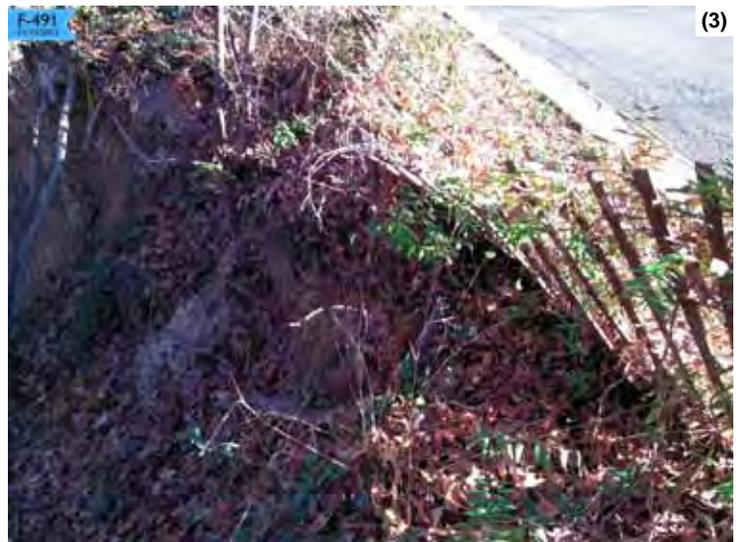
Stream Bank / Pool	<input type="text" value="3"/>	<input type="text" value="Severe Erosion"/>	Repairs Recommended? YES
Stream Bank / Pool (x2)	<input type="text" value="6"/>		
Structure	<input type="text" value="3"/>	<input type="text" value="Very Poor"/>	
Criticality	<input type="text" value="2"/>	<input type="text" value="Critical"/>	
Total Score	<input type="text" value="11"/>	<i>Total = Stream Bank / Pool x2 + Structure + Criticality</i>

Broken pipe and end structure. Severely eroded gully; depth approx 10-15 feet. Erosive sandy soils. Park Drive regenerative stormwater conveyance project is already in progress.
