OUTFALL SUMMARY REPORT

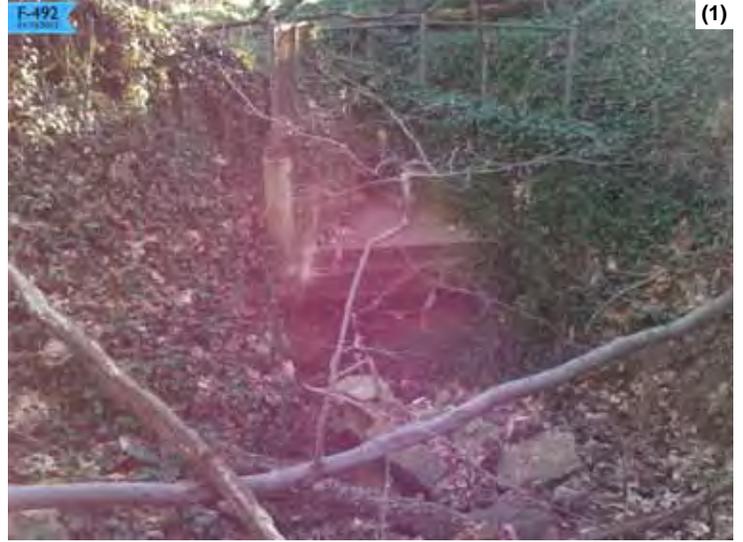
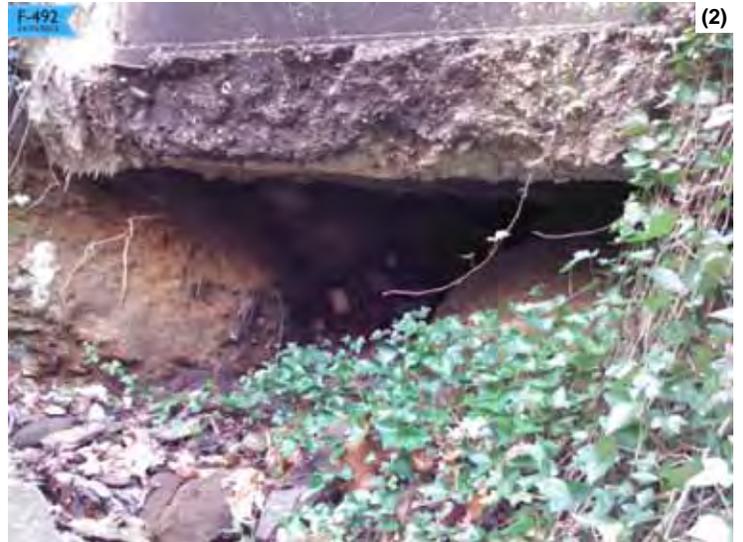
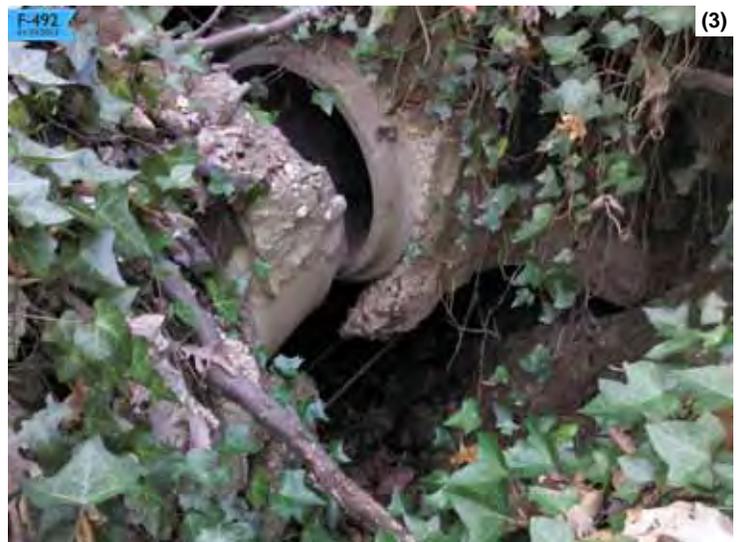
Stream Bank / Pool	<input type="text" value="3"/>	<input type="text" value="Severe Erosion"/>	Repairs Recommended? YES
Stream Bank / Pool (x2)	<input type="text" value="6"/>		
Structure	<input type="text" value="3"/>	<input type="text" value="Very Poor"/>	
Criticality	<input type="text" value="0"/>	<input type="text" value="Normal"/>	
Total Score	<input type="text" value="9"/>	<small>Total = Stream Bank / Pool x2 + Structure + Criticality</small>

Outfall has caused a erosion of a ravine downstream. Outfall structure has collapsed and been undermined. Water now flows from pipe behind headwall.

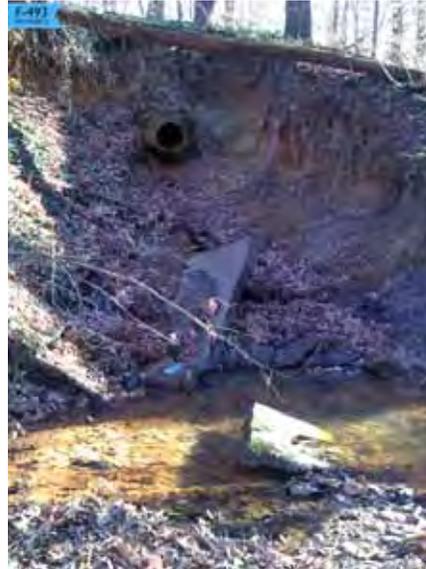
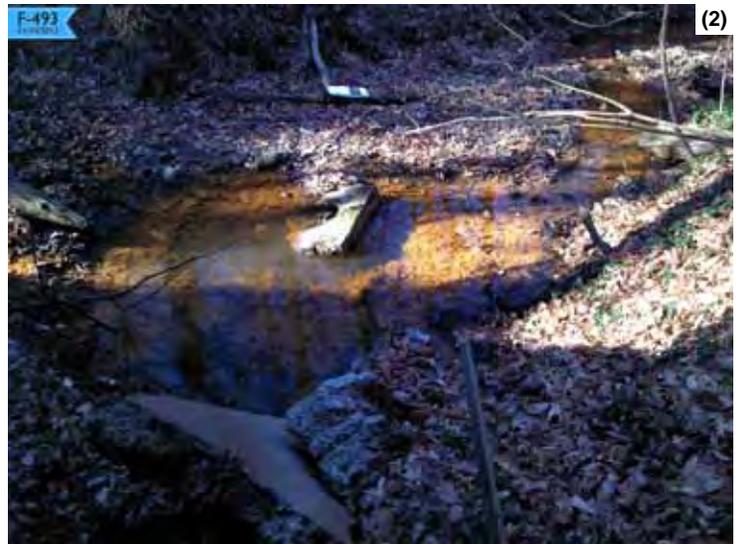
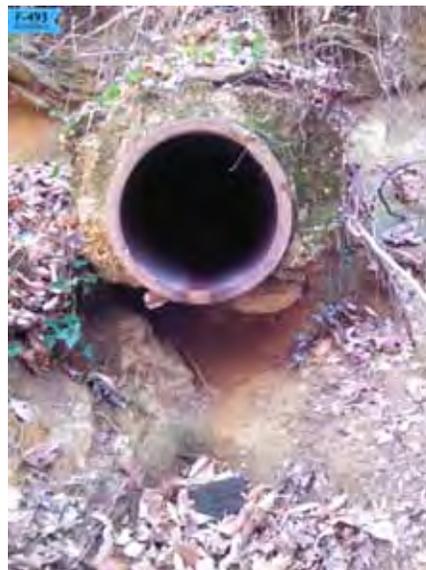
Stream Bank / Pool	<input type="text" value="3"/>	<input type="text" value="Severe Erosion"/>	Repairs Recommended? YES
Stream Bank / Pool (x2)	<input type="text" value="6"/>		
Structure	<input type="text" value="2"/>	<input type="text" value="Poor"/>	
Criticality	<input type="text" value="0"/>	<input type="text" value="Normal"/>	
Total Score	<input type="text" value="8"/>	<small>Total = Stream Bank / Pool x2 + Structure + Criticality</small>
